URGENT - Field Safety Notice

Medical Device Correction

Vereos PET/CT Vereos Cover Alignment Issues

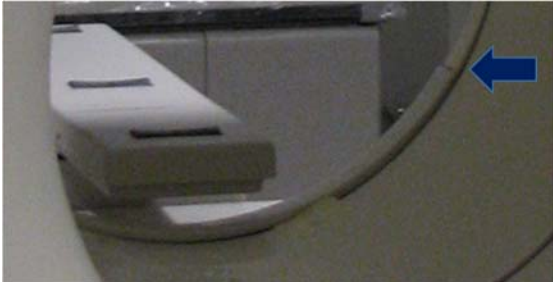
AFFECTED PRODUCTS	Vereos PET/CT System - 882446
PROBLEM DESCRIPTION	<p>The Vereos system may have gaps and/or alignment issues with Gantry Front and Rear Covers. This may result in corners on the Front and/or Rear Cover which do not follow the shape of the bore covers and may protrude into the bore diameter.</p> <p>Below pictures illustrates examples of potential gaps in the Front and Rear Cover.</p> <div style="display: flex; justify-content: space-around;">

</div>
HAZARD INVOLVED	<p>Gaps created due to Front and/or Rear Cover alignment may create a potential for accessories to collide with covers, or create a trapping zone for patient anatomy and/or items connected to the patient.</p> <p>In case of collision, the scan may be interrupted by the operator and/or E-Stop, causing the need to repeat a CT or PET acquisition.</p>
HOW TO IDENTIFY AFFECTED PRODUCTS	All installed Vereos PET/CT systems.

ACTION TO BE TAKEN BY CUSTOMER / USER	<ul style="list-style-type: none"> • The operator is instructed to observe the patient during motorized motion. In case of collision, the operator should use the E-Stop to abort all motions. • The operator is instructed to ensure accessories do not collide with gantry covers. Additionally, ensure that sheets, blankets and/or IV lines are not loose or hanging outside the Patient Pallet. • Ensure the patient's arms/hands are positioned appropriately at their side or overhead. If necessary, use the arm restraint strap as described in the IFU. • Instruct the patient to not move their hands during the scan and during any table motions until the operator removes the patient from the scanner at the completion of the study.

ACTIONS PLANNED BY PHILIPS	Philips Healthcare is notifying the affected users of the issues via this Field Safety Notice. Field Change Order (FCO) 88200520 will be deployed free of charge to address overall cover fit on the affected systems. A Philips Field Service Engineer will contact you to schedule the updates at your site.
FURTHER INFORMATION AND SUPPORT	If you need any further information or support concerning this issue, please contact your local Philips representative: For North America and Canada, contact the Customer Care Solutions Center (1-800-722-9377, follow the prompts).
