Customer Safety Advisory Notice (CSAN): AX030/20/S

Subject: Customer Safety Advisory Notice concerning the repair of the X-ray Generator with an integrated Energy Storage Unit (ESU) which is included in certain Cios Spin & Cios Alpha systems.

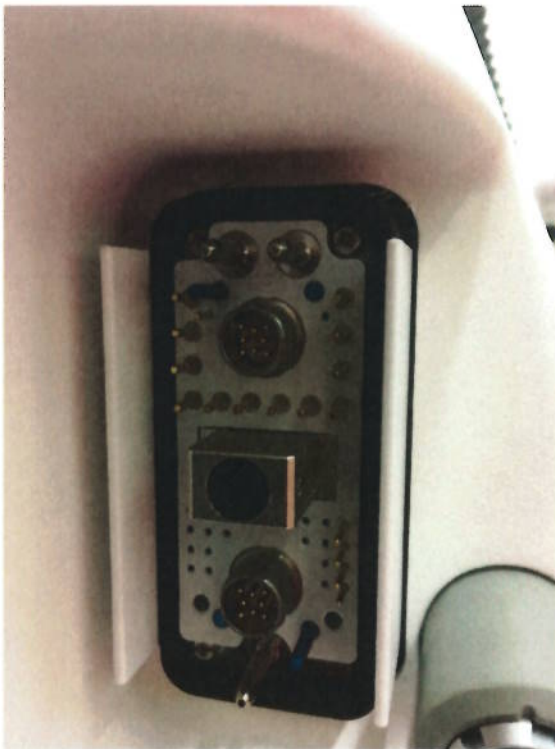
figure 3: example of X10 connector without the plug of the main cable being plugged in

Until the problem has been solved by our service team, we strongly recommend to not disconnect the main unit from the monitor trolley when the system displays the following system error message: "Err 16305 / 80: Confirm this error and repeat your last action".

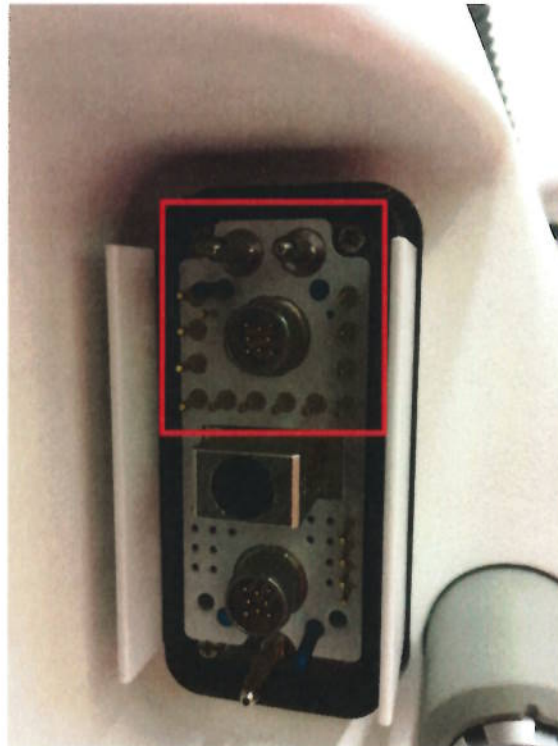
figure 2: example of X10 connector contact pin area which must not be touched

but there is a danger to health and life of the risk of an electrical shock when the main cable the contact pins of the X10 connector.

examinations in connection with a previously cause is a design flaw in a generator
