Customer Safety Information (CSI) for Field Safety Corrective Action: AX028/20/S

Subject: Customer Safety Information concerning the repair of the x-ray generator Polydoros M25 revision 04 which is included in certain Cios Spin & Cios Alpha systems.

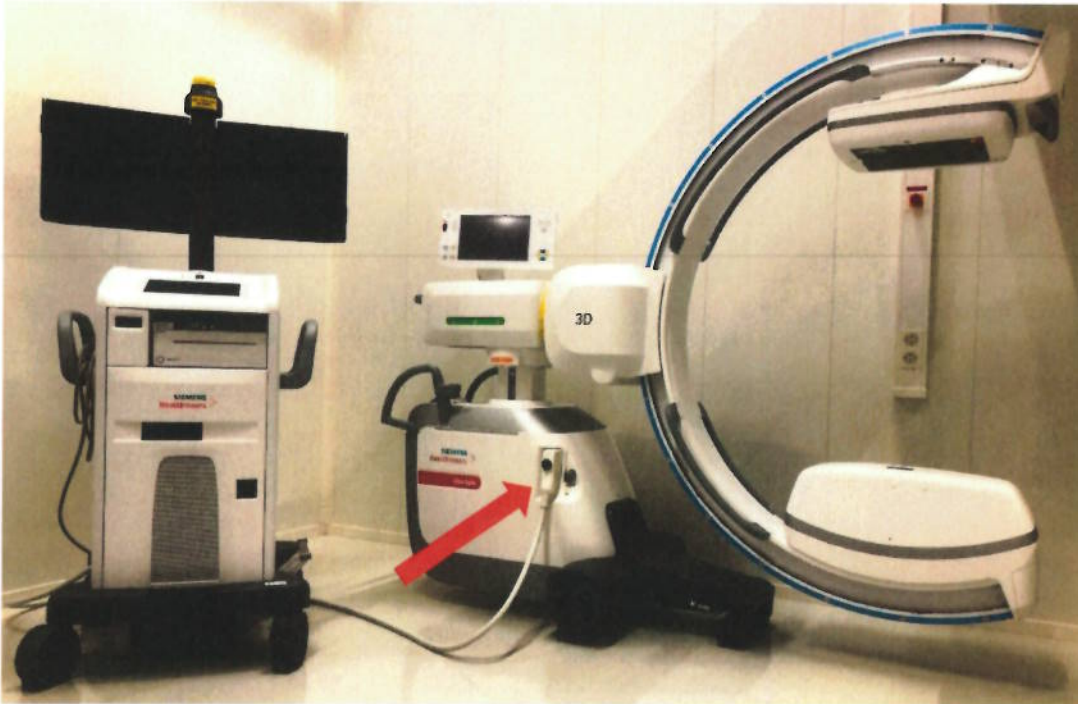
During the operation of the Cios system the monitor trolley of the Cios system is electrically connected with the main unit (c-arm) of the Cios System by a main cable. The main cable can be plugged or unplugged from the X10 connector which is part of the main unit (c-arm) at any time during clinical session (see figure 1 and 2). The unplugging of the main cable can cause an unsafe electrical voltage (up to 67,6 V DC) at the X10 connector which can result in an electrical shock if the user or other persons touch the contact pins of the X10 connector. These contact pins of the X10 connector are accessible when the main cable is unplugged from the X10 connector (see figure 2 and 3).

figure 1: example of monitor trolley connected to the X10 connector of the main unit (c-arm) by main cable

We strongly recommend to not unplug the main cable until the generator is repaired by a service engineer.

A service engineer will repair the generator of your affected system at your site.

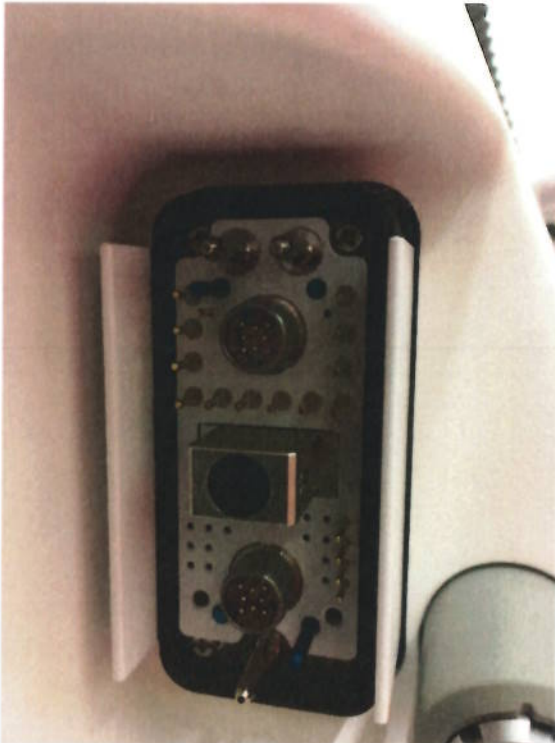
figure 3: example of X10 connector without the plug of the main cable being plugged in

There is no impact to the operation of the system but there is a danger to health of the user or other persons due to the above described risk of an electrical shock when the main cable is unplugged and the user or other persons touch the contact pins of the X10 connector.

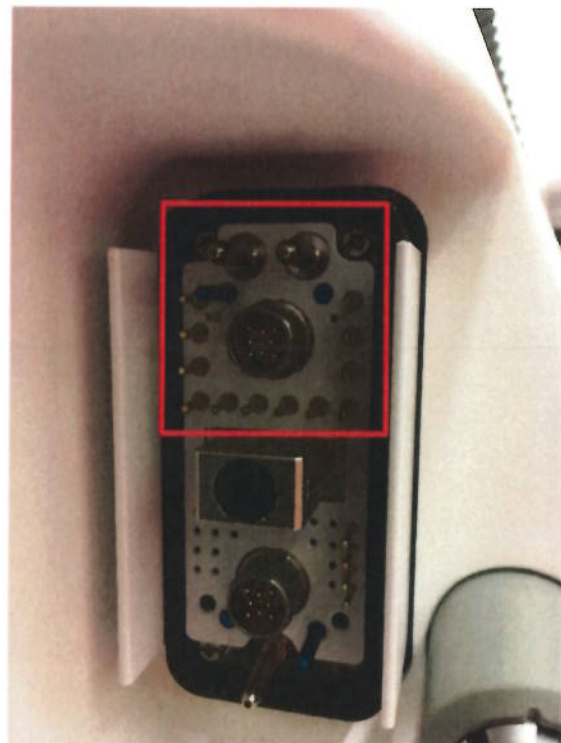
figure 2: example of X10 connector contact pin area which must not be touched

The problem was identified by the manufacturer during system assembly when the plug of the main cable was unplugged. The root cause is a design flaw in a generator component of the generator Polydoros M25 revision 04.

After repair of the generator the root cause which led to the unsafe electrical voltage at the X10 connector will be eliminated.
