## **Urgent Field Safety Notice**

### **SynchroMed® II Implantable Infusion Pump - Models 8637-20, 8637-40**

#### **SynchroMed® II Missing Propellant - Physician Letter Important Patient Management Recommendations**

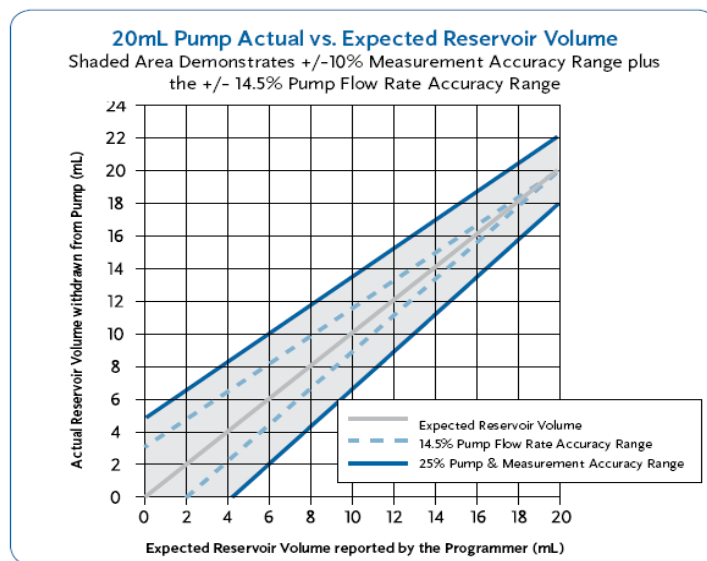
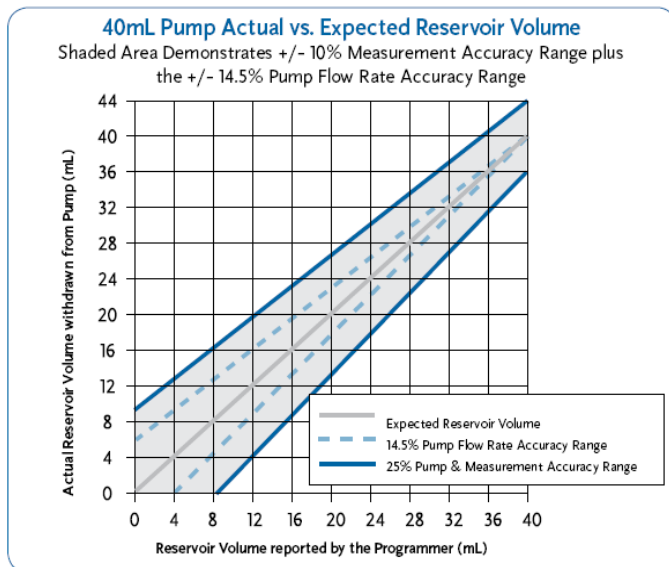
If necessary, use the Flow Rate Accuracy Charts below to help determine if a residual volume is within the error measurement guidelines.

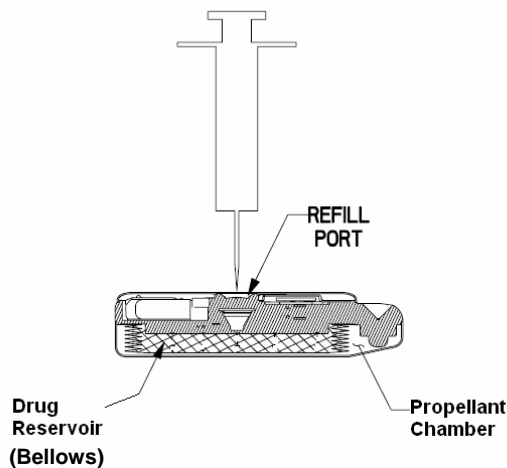
**Normal Pump**

Drug is contained in an expandable reservoir, also referred to as a ‘bellows’. The device is shipped with the bellows full of sterile water. The bellows is enclosed within the propellant chamber which contains a specific volume of propellant (in the form of a gas) that exerts pressure on the reservoir. The gas pressure is the primary force which drives drug to the pump mechanism, which dispenses drug based on the programmed rate. If a pump is missing propellant, at the point at which approximately one-half of the reservoir contents are removed, there will be insufficient force in the system to drive the drug to the pump mechanism, resulting in zero output from the device regardless of the programmed dispensing rate.
