Urgent Field Safety Notice

Risk of Minute Ventilation artefact oversensing in patients with a subset of abnormal high polarization XFine passive pacing leads, when connected to ALIZEA / BOREA pacemakers.

FSCA identifier: CRM-SAL-2022-001

Affected devices: Subset of MicroPort CRM XFine leads (models XFine TX25D, XFine TX26D, XFine JX24D; XFine JX25D) connected to MicroPort CRM ALIZEA or BOREA pacemakers (models ALIZEA DR 1600, ALIZEA SR model 1300, BOREA DR model 1500, BOREA SR model 1200).

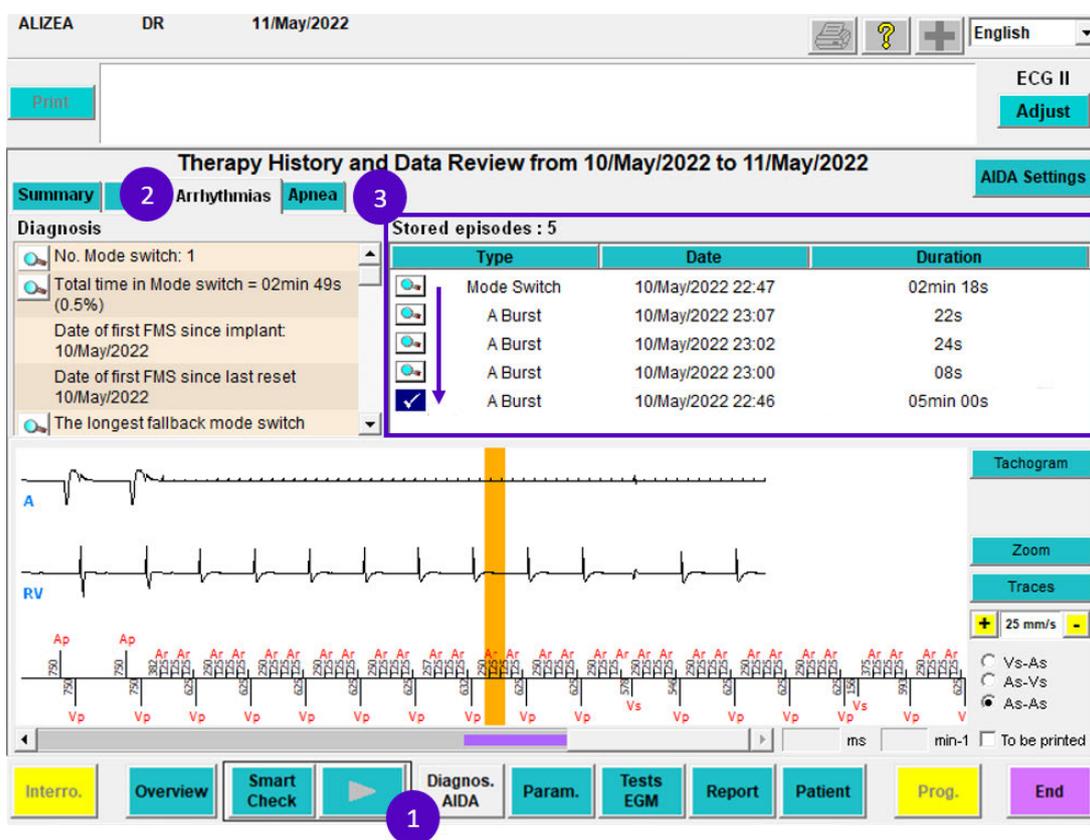
Figure 1: Sequence for checking the presence of MV oversensing in recorded episodes

MV oversensing might be visible in episodes stored in the device memory, as:

- “A Burst” or “V Burst” episodes for SR pacemakers;
- “A Burst” or “Mode Switch” episodes for DR pacemakers.

After interrogation of ALIZEA or BOREA pacemakers with Orchestra Plus or SmartTouch programmers:

1. Select the “Diagnos. AIDA” tab in the menu bar at the bottom of the screen;
2. Select the “Arrhythmias” tab;
3. Check recorded episodes individually to identify the presence of MV oversensing.
