Type of Action: Field Safety Notice

Field Action Identifier: FA 2021-010-002-LUL-001

Subject: Missing bushing on Liko M220 and M230 causing wear and potential for falls.

Commercial name of affected product: Liko M220, Liko M230

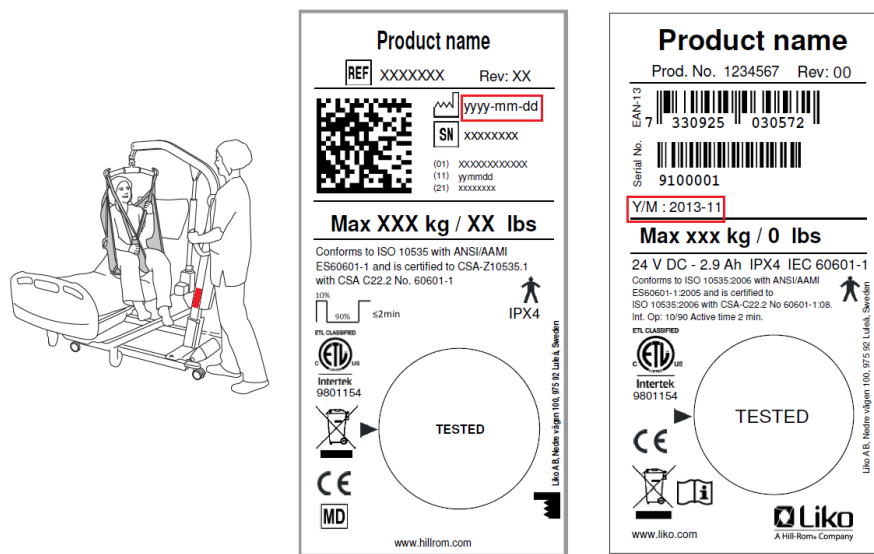
1. Review the product label on your Liko M220/M230 to determine if it is impacted by this field action by identifying the manufacturing date of the device (i.e. Manufacturing date between 2016-DEC-27 and 2021-SEP-01). See figure 2.

Figure 2: Placement of the label and its designs. Left: New design. Right: Old design.

2. Please periodically inspect your Liko device for damage or wear. Report visible wearing or damage to your Technical Support Team – do not use the device until Technical Support can inspect and repair where necessary.
3. Please fill out the attached response form and return it to Hillrom hillromLUL001OUS@sedgwick.com within two weeks.
