URGENT Field Safety Notice

Allura Xper, Allura Centron, and Azurion systems
Potential loss of imaging functionality resulting from no or intermittent X-ray radiation initiation through the wired foot switch.

15-August-2023

Reference: 2023-IGT-BST-004: Allura Xper, Allura Centron, and Azurion Systems.

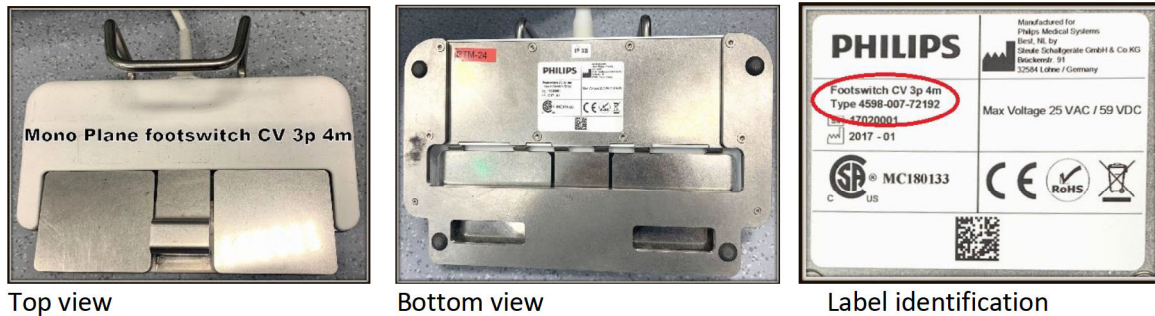
The reference/type of the wired foot switch can be found on the label located on the bottom of the wired foot switch, as shown in Figure 1.

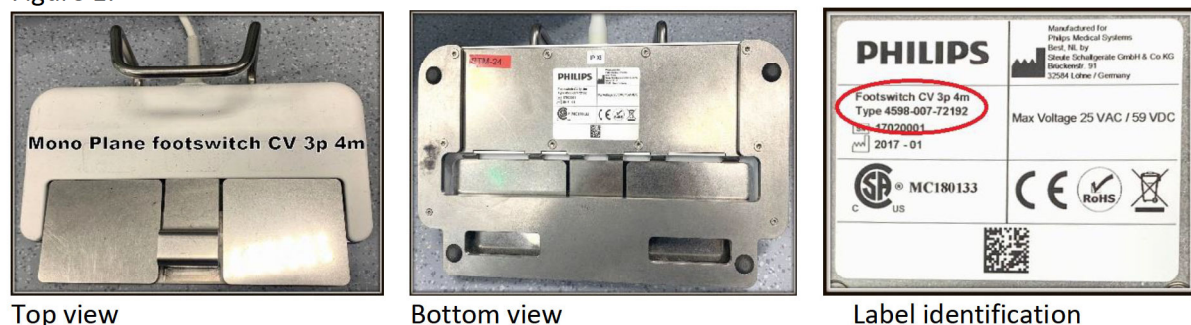
The reference/type of the wired foot switch can be found on the label located on the bottom of the wired foot switch, as shown in Figure 1.
