**URGENT Field Safety Notice**  
**ProxiDiagnost N90 1.1 and ProxiDiagnost Upgrade**

Software Defects causing imaging issues during Radiography and Fluoroscopy examination

05-December-2023

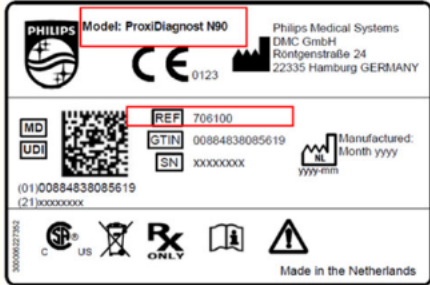
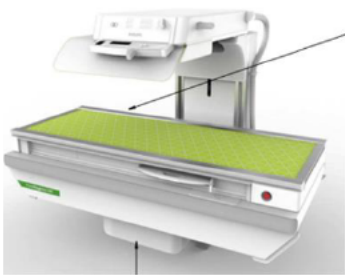
**Figure 1. Impacted Systems**

Refer to Figure 1 for the list of impacted model names and model numbers (REF). The model name and model number (REF) can be found on the system label.

ProxiDiagnost N90	706100 706110
		ProxiDiagnost upgrade	706150
