Urgent Medical Device Field Safety Notice

2.24 programmer software version and Reply / Esprit pacemakers

Technical Note associated to the Field Safety Corrective Action
on Smartview 2.24 and Reply / Esprit pacemakers

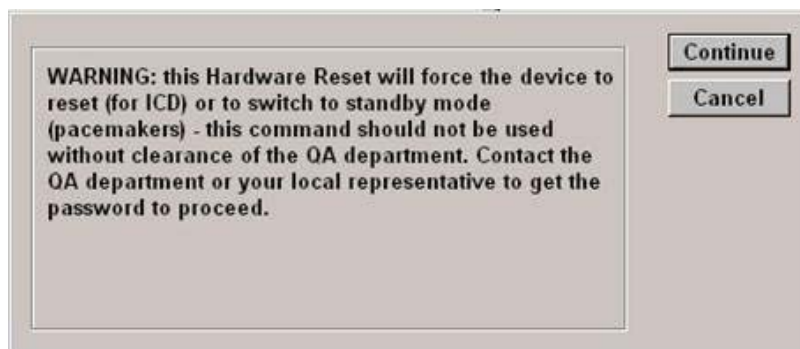
4. Press “OK”. After that, the following pop-up is displayed:

5. Press “Continue”. Then, you shall enter the password in accordance with the programmer software version currently installed on your programmer:

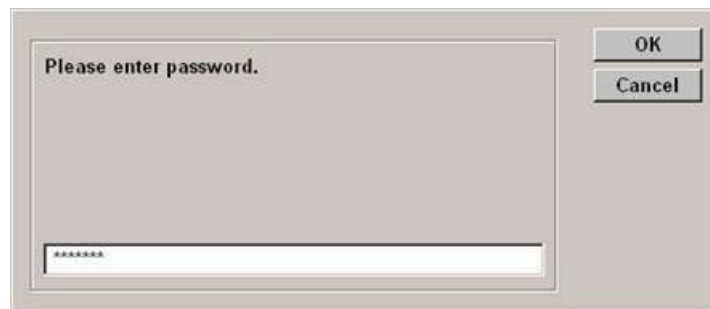
Note: the password is case sensitive, and letters are in uppercase.
For a letter: Press “Shift” key + “Letter” key
For a digit: Press “Digit” key only

If the password is entered correctly, the reset is performed and a message "Reset successfully performed" is displayed. At this time, the device is programmed in standby mode (VVI mode, 5V, 0.5ms, 70min-1).
