FIELD SAFETY NOTICE ALERT

Team3 Fetal Monitor

Resolution in summary:	Upgrade Fetal Monitor with revised software (v19.4)
No pages:	15 inclusive of the declaration form

FSN01-23

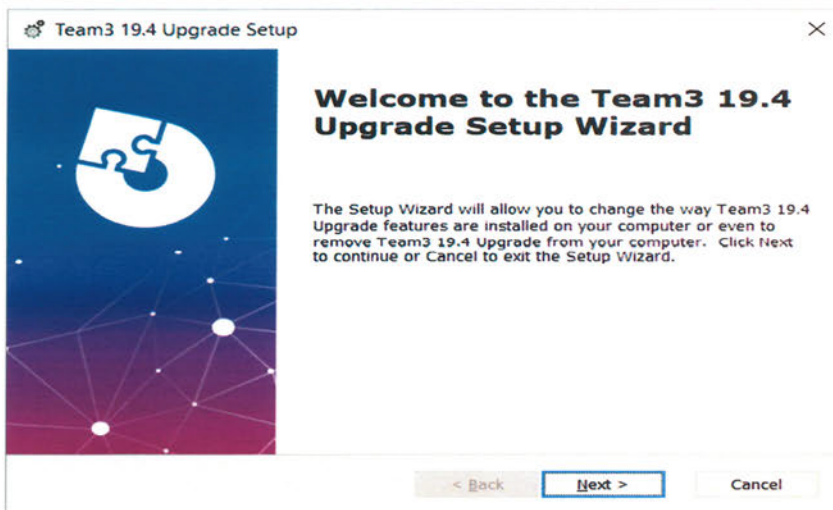
Once downloaded, run the executable 'Team3 19.4 Upgrade.exe' to install the software on the PC. Right click on the executable, select 'Run as administrator', and enter administrator credentials. The Setup Wizard will be displayed:

Follow the steps of the Setup Wizard to complete the installation.

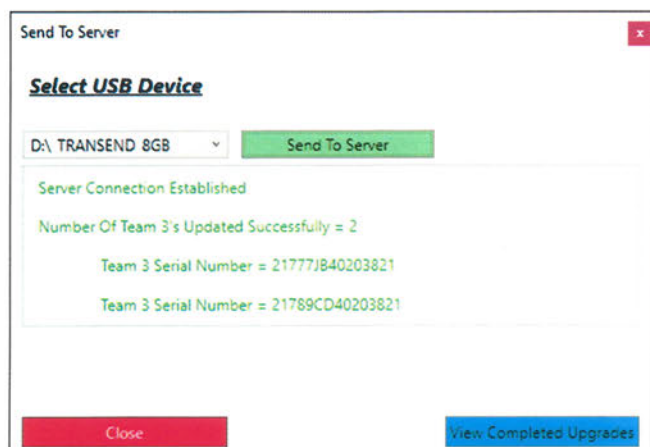
Click on the 'Send To Server' button to display the Send To Server dialog box.

Select the upgrade USB stick from the drop down list and click the 'Send To Server' button. A list of the Team3 Units upgraded using the stick is displayed in the scrollable message box. If a server connection could not be made, please try again later.

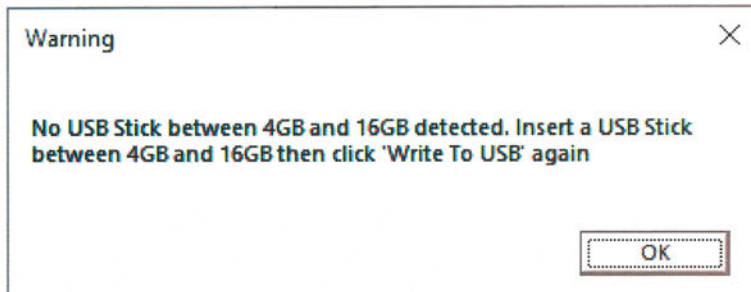
If there is no suitable USB memory stick inserted when trying to write the upgrade files, the following message is displayed:

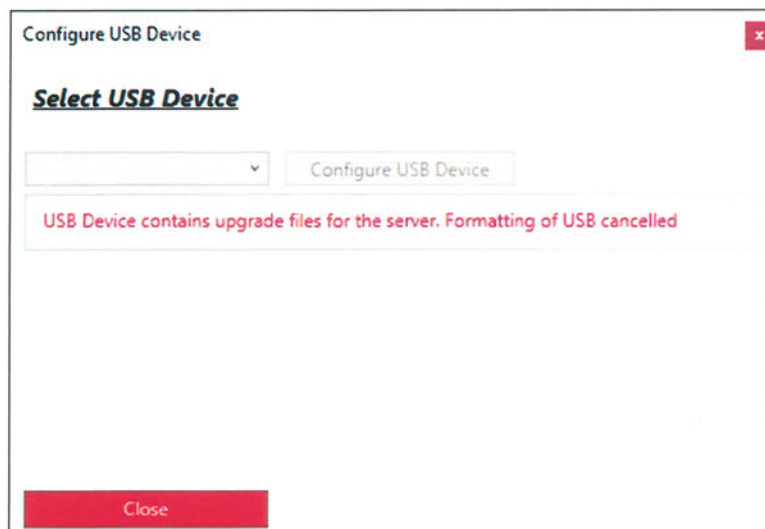
If the USB memory stick contains log files created during an upgrade operation, the following message is displayed when trying to write the upgrade files:

In this case, close the dialog box and replace the USB stick to before trying again.
