Field Safety Information

Olympus ETD2 / ETD2 Plus / mini ETD: Blocked adapter XMB-109 and EUS-XMB-109

Annex 1: Adapter identification

Annex 2: Test procedure on adapter patency

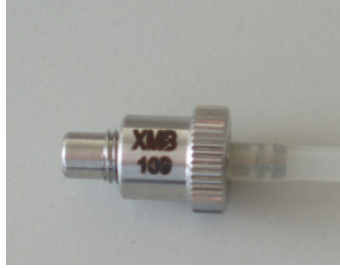
Figure 1: The adapter XMB-109 can be identified by the laser imprint.

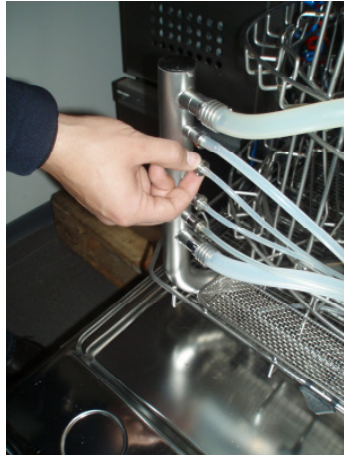
Figure 1: Disconnect the adapter from ETD2 / mini ETD. Perform the test outside of ETD machine by using a syringe.

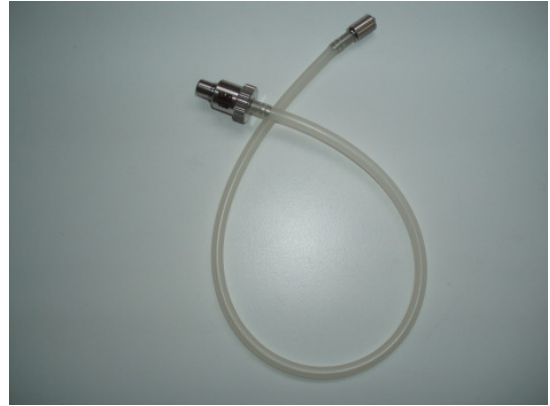
Figure 2: Test all adapters with the laser imprint XMB-109. Test the complete adapter. Do not dismantle the adapters.

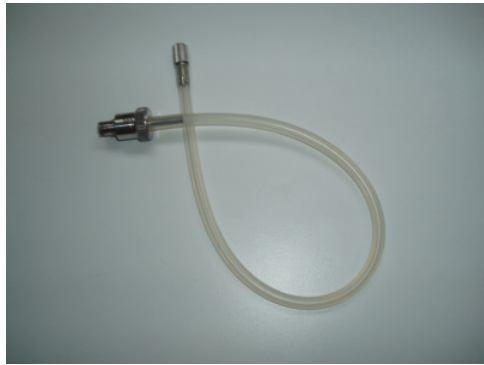
Figure 3: Test all adapters with the laser imprint EUS-XMB. Test the complete adapter. Do not dismantle the adapters.

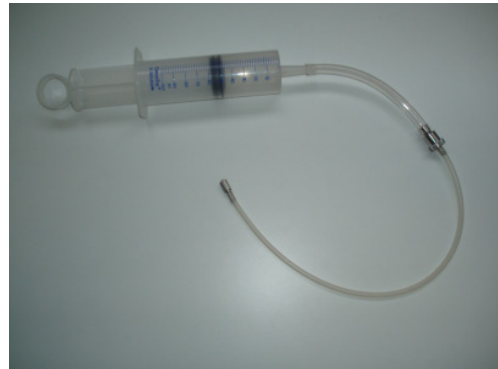
Figure 4: Connect the syringe via a silicone tube to the adapter, while applying the same flow direction as in the ETD machine.

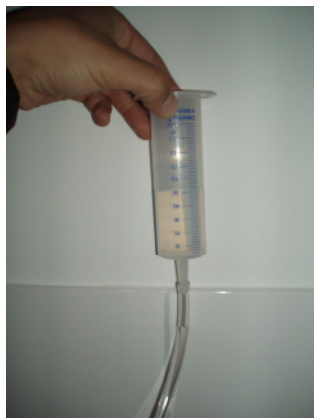
Figure 5: Remove the piston of the syringe and fill in 50 ml of water

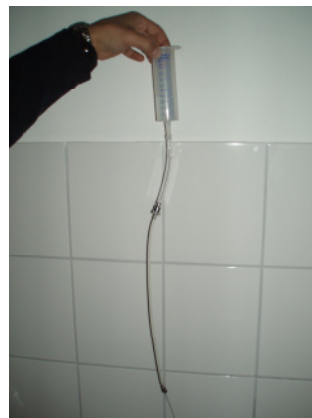
Figure 6: Water will flow through the adapter. By gravity 50 ml will flow out within a maximum of 60 seconds. If no water flows through the adapter, inform Olympus

The patency of the adapters shall be checked according to the procedure outlined in annex 2 to this letter. In case you identify a blocked adapter, do not use this adapter anymore and inform immediately your local Olympus service representative. The service will inform you about further action.
