URGENT FIELD SAFETY NOTICE

GEHC Ref# 60952

RE: AIR Anterior Array coil outer seam separation

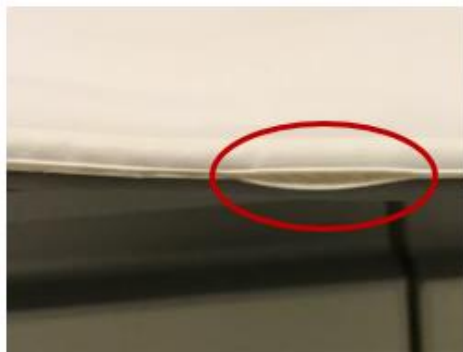
The outer seam of the coil, closest to the system cable, may separate and expose the porous material internal to the coil. This could result in user and/or patient contact with infectious agents since the internal porous material cannot be disinfected. No injury has been reported to GE as a result of this issue.

Figure 1 example of separated seam

You can continue to use the coil by following the existing Operator Manual Safety Information. This safety information includes:

WARNING: Use only coils, cables and accessories that are in good condition. Before using the coil, visually check each coil component, cable and accessory to ensure that there is no external damage. Visually check the coil for tears or damage to make sure no internal conductors are exposed. If any coil component, cable or accessory is suspected of not being in good condition, discontinue use and contact a GE Service Engineer.

GE Healthcare will correct all affected products at no cost to you. A GE Healthcare representative will contact you to arrange for the correction.
