Urgent Field Safety Notice

Cemento Mini Set for Cemento-MP

Urgent Field Safety Notice (FSN)
Cemento Mini Set for Cemento-MP

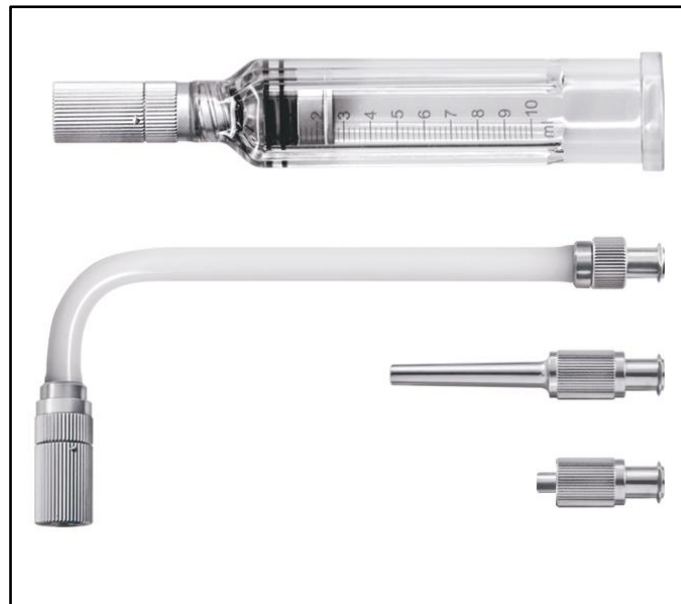
Fig. 1: Optimed Cemento Mini Set for Cemento-MP

1. Information on Affected Devices*	
1.	1. Device Type(s) Cemento Mini Set for Cemento-MP: complementary set with injection cylinder, connection hose, aspiration cannula, and Luer Lock adapter (see fig. 1 above)
1.	2. Commercial name(s) Cemento Mini Set for Cemento-MP
1.	3. Unique Device Identifier(s) (UDI-DI) n/a
1.	4. Primary clinical purpose of device(s) The optimed Cemento MP is an injection system for cemetoplasty / vertebroplasty.
1.	5. Device Model/Catalogue/part number(s) 1382-0100
1.	6. Software version n/a
1.	7. Affected serial or lot number range 13622, 13661, 13712, 13822
1.	8. Associated devices n/a

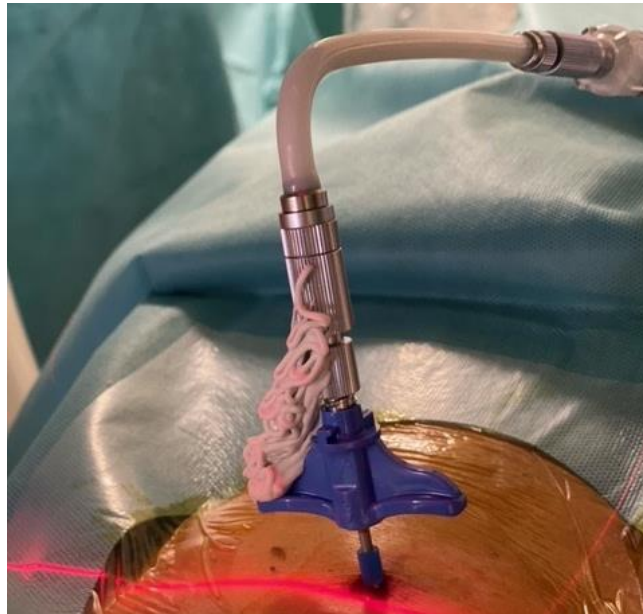
2 Reason for Field Safety Corrective Action (FSCA)	
2	1. Description of the product problem In recent weeks, in very rare cases, an unexpected leakage of the cement mixture occurred at the distal luer lock of the connection hose (see fig. 2)
2	2. Hazard giving rise to the FSCA We have been informed about 4 cases with cement leakage; none of the patients has been harmed. The user can clearly see the leakage of the cement because it happens outside the patient. When the user notices a leakage, he must use a new set. Since the cement cannot be applied into the patient in case of a leakage, there is no risk to the patient. We decided to recall the affected products, because the malfunction is not acceptable, even if there is no risk for the patients.
2	3. Probability of problem arising There are four lots which may be affected by this leakage. 697 mini sets of these four lots has been delivered by optimed, and four cases of leakage has been reported. The complaint rate is 0.57%.

2	4. Predicted risk to patient/users According to the available information, there is no risk for patients.
2	5. Further information to help characterise the problem n/a
2	6. Background on Issue The root cause was identified as a deviation in the tolerance during production of the rotatable Luer lock connection. Only products of the 4 above-mentioned lots can be affected by this manufacturing defect. Other lots are not affected by this possible defect.
2	7. Other information relevant to FSCA Other lots of this part number and other products are not affected.

Fig. 2: Leakage at distal Luer Lock of the connection hose

3. Type of Action to mitigate the risk	
3.	<p>1. Action To Be Taken by the User</p> <p> <input checked="" type="checkbox"/> Identify Device <input checked="" type="checkbox"/> Quarantine Device <input checked="" type="checkbox"/> Return Device <input type="checkbox"/> Destroy Device </p> <p> <input type="checkbox"/> On-site device modification/inspection </p> <p> <input type="checkbox"/> Follow patient management recommendations </p> <p> <input type="checkbox"/> Take note of amendment/reinforcement of Instructions For Use (IFU) </p> <p> <input type="checkbox"/> Other <input type="checkbox"/> None </p> <p>The affected products should no longer be used on patients. Quarantine all affected products and return all products of the affected lot.</p>
