Dimension Vista® Intelligent Lab Systems

Dimension Vista® Elevated Triglyceride Results after Millipore Progard Pretreatment Pack Replacement

Reason for Correction

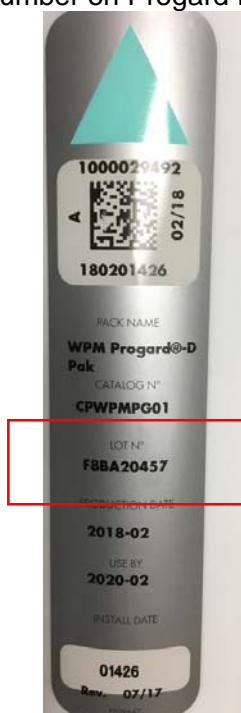
Figure 1: Lot Number on Progard Pretreatment Pack

If you have received a Progard Pretreatment Pack with a lot number listed in Table 1 and shown in Figures 1 and 2, please follow the steps below upon Progard Pretreatment Pack installation with use of the lots indicated in Table 1.

1. Verify your water tank level is 85% or less on the WPM Maintenance screen (press Setup > Supplies > Maintain Water Supply > Maintenance). If your tank level exceeds 85%, use the Advanced->Diagnostics->Prime Pumps routine to lower the tank volume.

2. Replace the Progard filter and perform any other required maintenance as instructed in Section 7 of the Dimension Vista System Operator's Guide.
3. After the Progard procedure completes, pause the instrument (Operation > Pause), and return to the WPM Maintenance screen (press Setup > Supplies > Maintain Water Supply > Maintenance)

4. Select the "Refill Tank" button. The process will take approximately 40 minutes to complete. An estimated time remaining is shown in the graphical user interface (GUI), and the white Status boxes in the top right indicate the steps of the process.

5. When complete, exit the WPM GUI by pressing "Hide Window." An instrument reset is automatically performed as part of the process.
6. Process triglyceride QC and ensure all levels are in range. If QC is out of range, do not recalibrate triglyceride; contact your Siemens Technical Support Representative.
