URGENT - Field Safety Notification Medical Device Correction

Philips HeartStart MRx Monitor/Defibrillator on exceptionally rare occasions may exhibit abnormal behavior when operating using a single battery as the sole source of power.

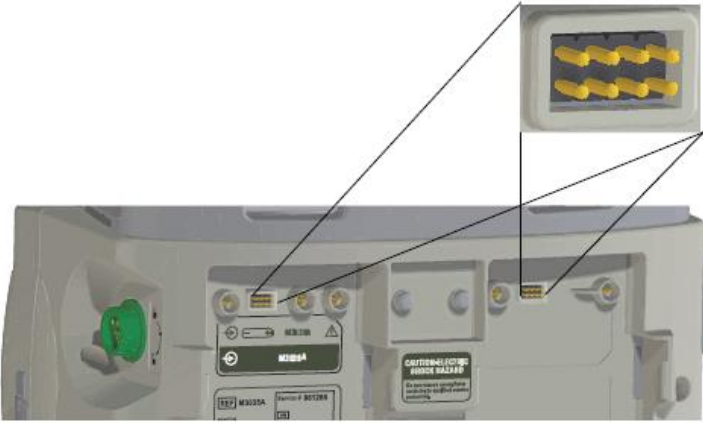
<p>BEHAVIOR DESCRIPTION 1</p>	<p>If the battery connecting pins (in the battery compartment of the HeartStart MRx Monitor/Defibrillator) become damaged or contaminated, it could result in a poor electrical connection that may cause the MRx to either (i) not power on or (ii) repetitively reboot, when used on battery power only.</p>
<p>HAZARD INVOLVED 1</p>	<p>HeartStart MRx Monitor/Defibrillator may, on exceptionally rare occasions, either (i) not power on or (ii) repetitively reboot. Either situation would make the device inoperative, delaying therapy to a patient in need of defibrillation, cardioversion, pacing, or monitoring.</p>
<p>ACTION TO BE TAKEN BY CUSTOMER / USER – 1</p>	<p>When inspecting the device, inspect the HeartStart MRx battery compartment connections. Include this step as part of a routine Operational Check to verify that the battery connector pins are clean, fully extended, not bent, and without residue.</p> <p>Figure A: Battery Connector Pins</p>

<p>Battery Connector pins, eight in each compartment</p>

<p>ACTIONS PLANNED BY PHILIPS - 1</p>	<p>Philips is voluntarily initiating this correction and is providing an Instructions for Use (IFU) Addendum entitled, <u>HeartStart MRx Battery Connector Pins</u>, for all customers with affected units.</p>

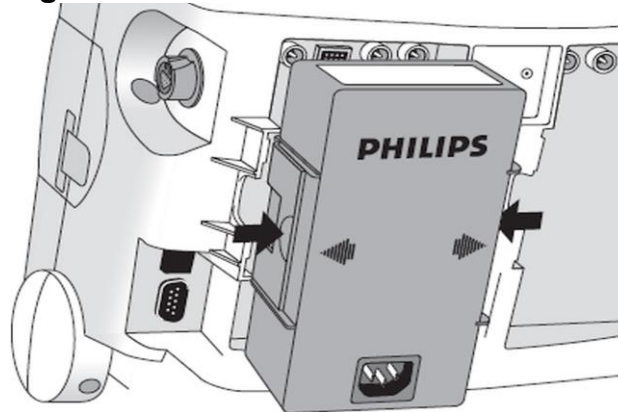
Figure C: AC Module Removal

- a. Remove the AC module from the MRx, rather than unplugging the cord from AC mains (see Figure C).
