Customer Information Letter Philips Efficia DFM100 Monitor/Defibrillator

Efficia DFM100 Monitor/Defibrillator False Low Battery Indication

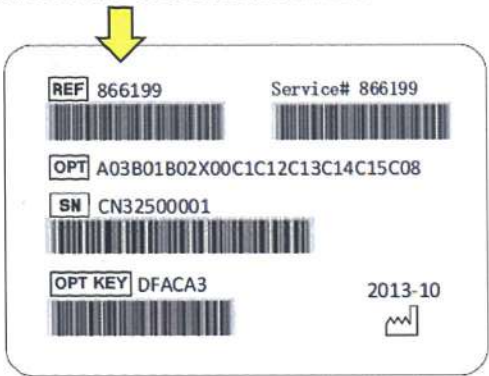
AFFECTED PRODUCTS	<p>Product: All Philips Efficia Defibrillator/Monitor (Model number 866199) manufactured prior to March-30th-2020.</p> <p>Affected Countries: Worldwide, excluding US and Canada</p>
PROBLEM DESCRIPTION	<p>Philips determined that the 866199 Efficia DFM100 Defibrillator/Monitor may give a false low battery indication, caused by a voltage inrush, when the battery is inserted or removed.</p>
HAZARD INVOLVED	<p>This false indication could cause a delay in therapy, or therapy not to be delivered, if operators believe that the DFM100 has insufficient battery power. A device with this failure will also be unable to recharge its battery.</p>
HOW TO IDENTIFY AFFECTED PRODUCTS	<p>The model number of the Philips Efficia DFM100 is printed on the primary label on the bottom of the device</p> <div data-bbox="512 1153 1002 1527">

<p>REF 866199 Service# 866199</p> <p>OPT A03B01B02X00C1C12C13C14C15C08</p> <p>SN CN32500001</p> <p>OPT KEY DFACA3 2013-10</p> </div>
