Urgent Field Safety Notice
IPELA FHD PTZ TILE KITS

Natus Field Service Personnel report that the Axis camera ceiling tile is not fitting properly in some domestic institution ceiling tile grids that have a thinner style grid frame.

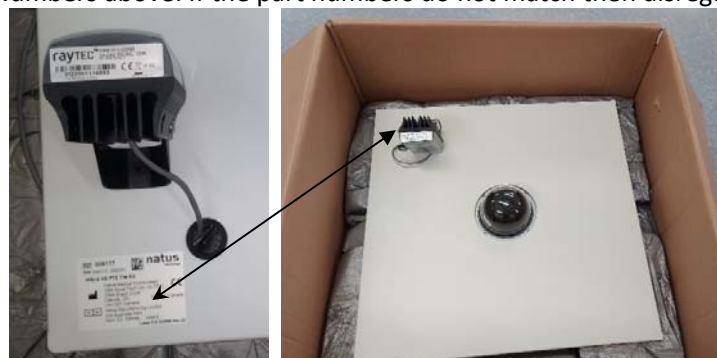
Step 1. Locate the product's label on the tile kit. The label part number should correspond to the affected Natus Part Numbers above. If the part numbers do not match then disregard this recall.

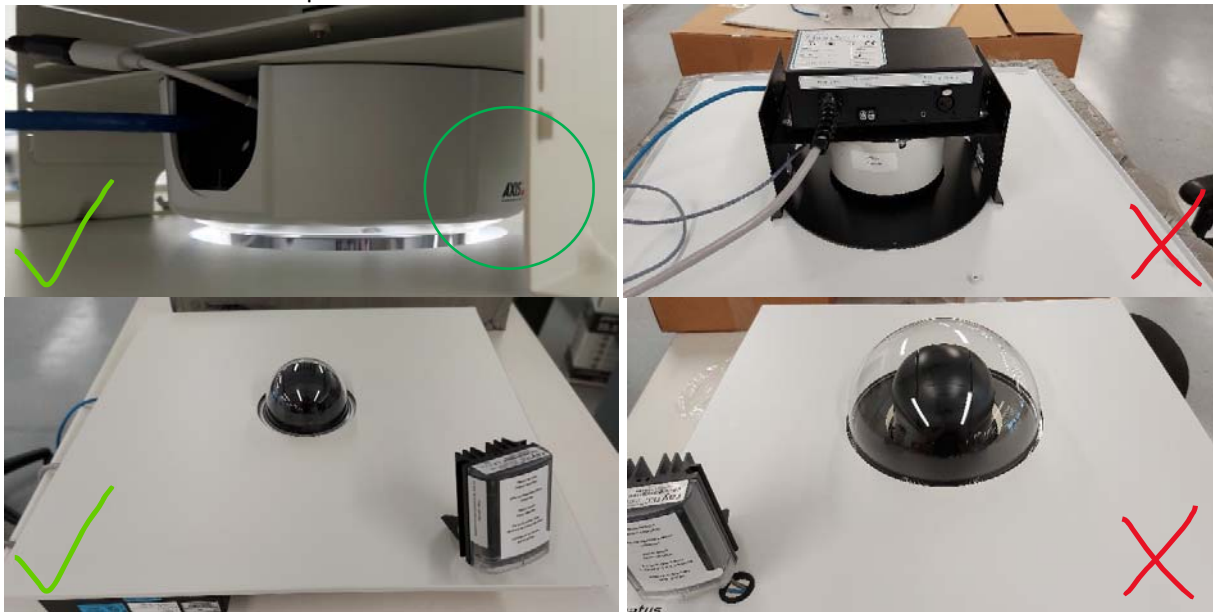
Look through an adjacent ceiling tile to identify the model of the camera installed. The camera model will either be Sony IPELA or Axis. The Axis camera can be identified with the “Axis communications” logo on the side of the camera housing indicated by the green circle in the upper left image below. For reference, image of kits using the Axis camera (showing a ‘✓’) and Sony IPELA camera (showing a ‘x’) are provided below. Note, the kit with an Axis camera also uses a smaller clear dome than the Sony Ipele as shown in the bottom two pictures below.

If you have identified the Sony IPELA camera, please disregard this recall. If you have identified the Axis camera, you are affected by the recall, please proceed to Step 3.
