URGENT FIELD SAFETY NOTICE
Cardioband Mitral Reconstruction System VSU04001

Reference: FCA-119

RE: Cardioband Mitral Reconstruction System IFU

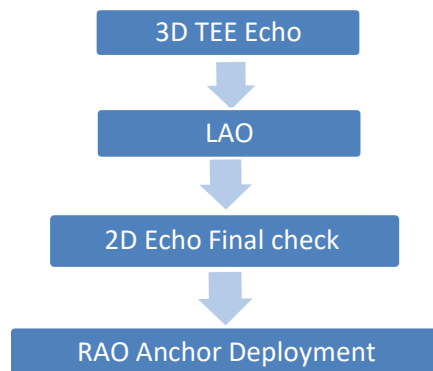
8. The imaging sequence below should be followed:
