Urgent Field Safety Notice

Labelling Error – Wrong Contents in Package

Affected Product: RABEA

REF	Description	LOT
WK061214	RABEA PEEK Cervical cage angled 6x12x14mm 5°	815993-KU

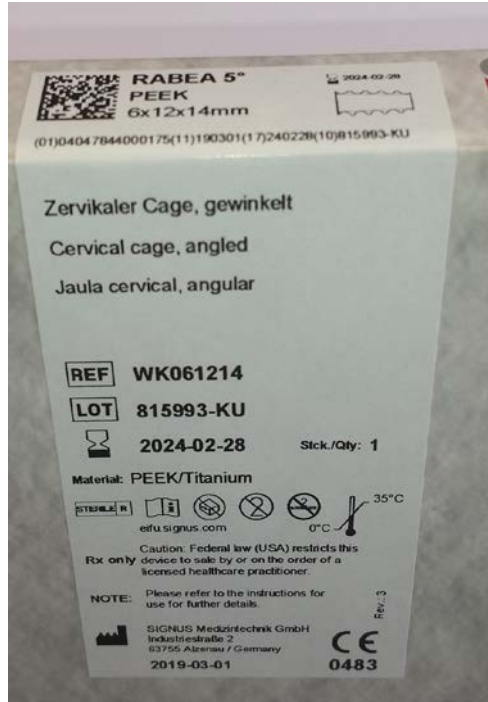
Label on Outer Packaging
Figure 1

The product RABEA and the only article code and lot number affected can be clearly identified by the product identification labels. Figure 1 shows the label on the outer packaging (folding box):

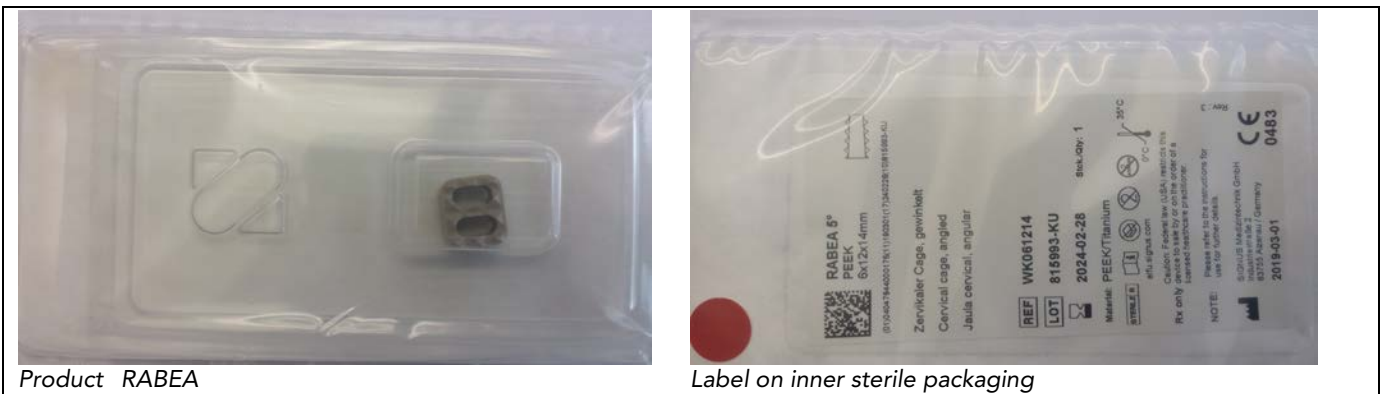
Figure 2

Figures 2 and 3 show the correct content of the folding box:

- Remove the protective film from the outer packaging without damaging the label
- Open the package at the bottom and compare the label on the folding box with the label on the sterile packaging as shown in fig. 2 and 3.
-

If the content matches the sample photos shown in figures 2 and 3, you can safely use the medical device.

If the content does **NOT** match the sample photos shown in figures 2 and 3, please **return the product** to us.

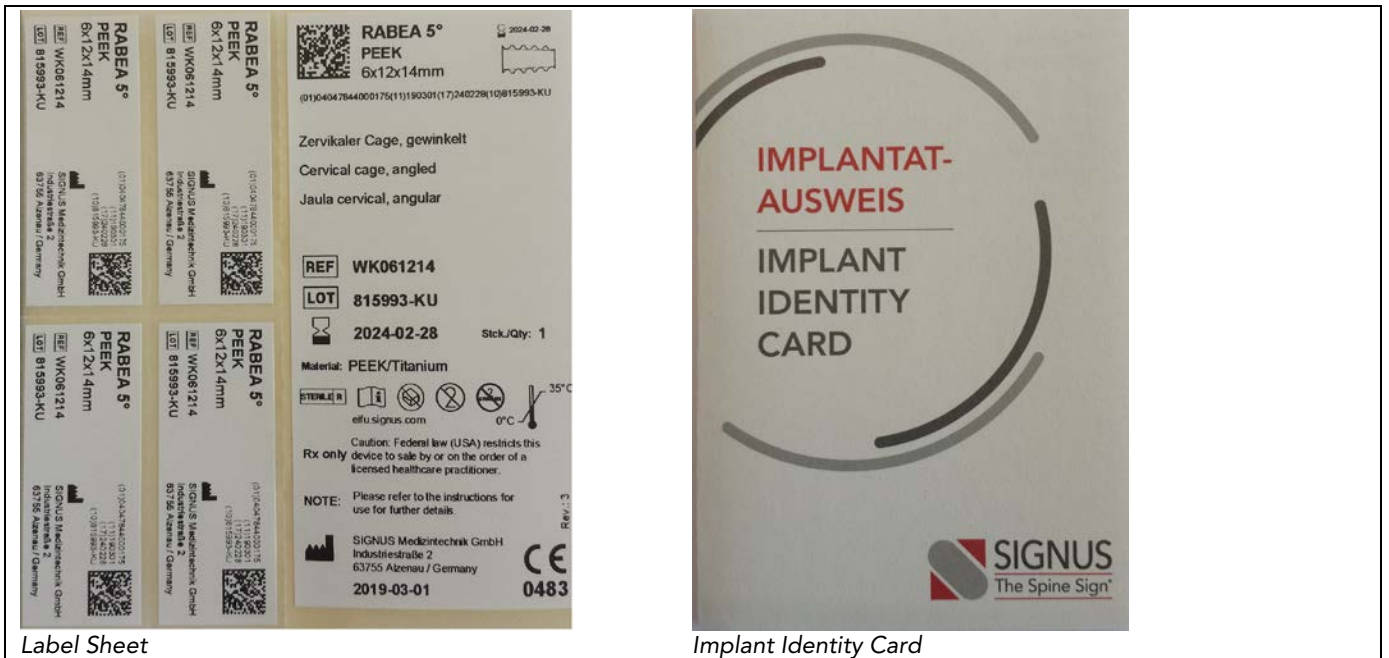
Figure 3

Label Sheet

Implant Identity Card

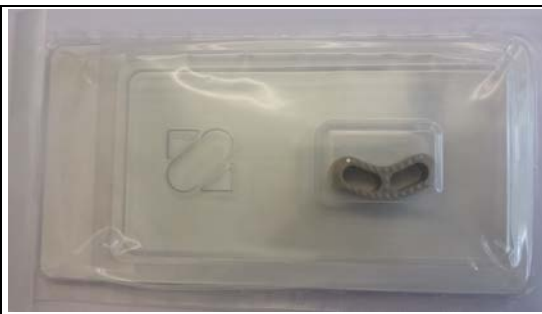
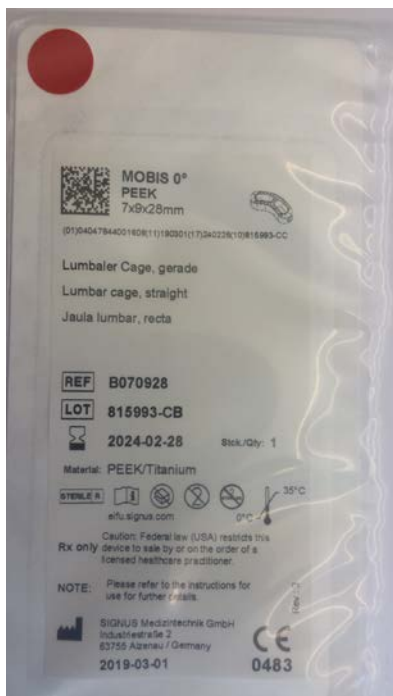
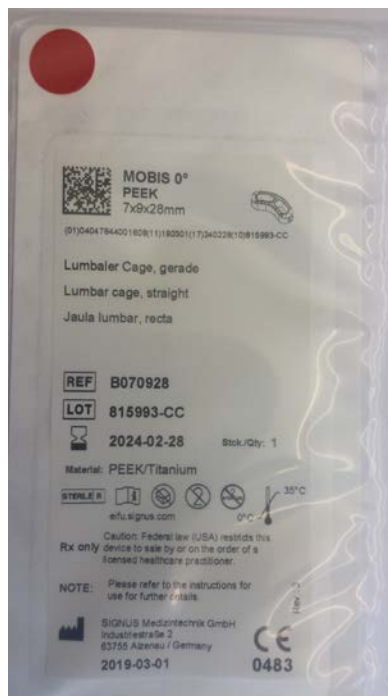
Figure 4 shows the possible **wrong content**:

This would be MOBIS, REF B070928, LOT: 815993-CB or LOT 815993-CC.

wrong product MOBIS

MOBIS labels on sterile packaging

Please use the **reply form attached** on page 6 for your feedback and return it by August 20th 2019. Thank you.
