**URGENT FIELD SAFETY NOTICE – PRODUCT RECALL**

MobileLink Acetabular Cup System, Shell/Insert Adapter

Shell/Insert Adapter for Shell 74-80 mm, Insert Size F, + 12 mm Offset 20° Inclination, Tilastan

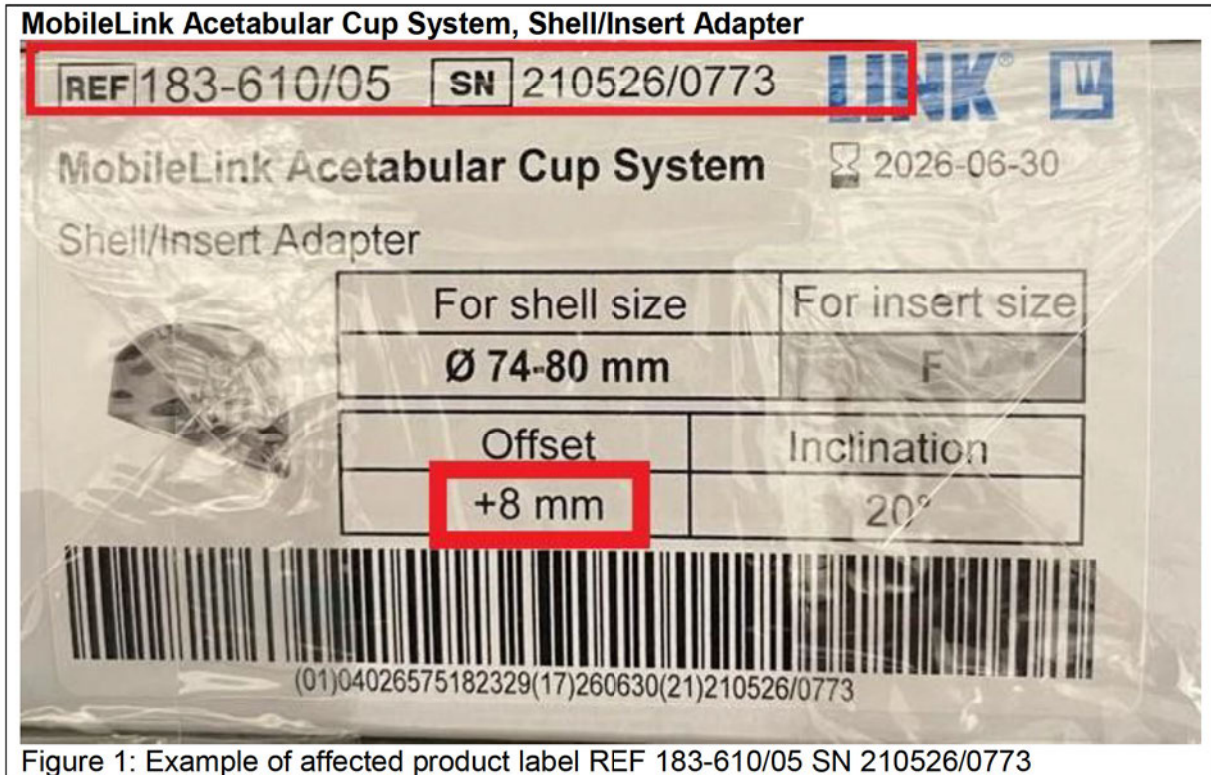
Figure 1: Example of affected product label REF 183-610/05 SN 210526/0773

Due to a complaint, it has come to our attention that the offset on the labels of the Shell/Insert Adapter does not match to the article REF and the description in the surgical technique. This only affects the article REF 183-610/05.  
For these products it should be +12 mm offset on all labels including the label for the implant card, but the Shell/Insert Adapter were incorrectly labelled as + 8 mm offset.  
The product in the packaging has a +12 mm offset, which is correct and fits to the article REF and the description of the surgical technique.

For patients who have already been treated, the implant card needs to be corrected manually: +12 mm instead of +8 mm offset.

<input checked="" type="checkbox"/> Identify Device
<input checked="" type="checkbox"/> Quarantine Device
<input checked="" type="checkbox"/> Return Device
<input type="checkbox"/> Destroy Device
<input type="checkbox"/> On-site device modification / inspection
<input type="checkbox"/> Follow patient management recommendations
<input type="checkbox"/> Take note of amendment / reinforcement of Instructions For Use (IFU)
<input checked="" type="checkbox"/> Other
<input type="checkbox"/> None
<ul style="list-style-type: none"><li>• Should you have any of the affected product in your inventory, please send the products back to Waldemar Link GmbH &amp; Co. KG.</li><li>• Replacement will not incur any costs to you. Should you have any question on acquiring replacements for forthcoming surgeries, please contact your local sales representative or customer service for Link products.</li><li>• For patients who have already been treated, the implant card needs to be corrected manually to reflect the correct offset to +12 mm.</li><li>• Please return the reply form to us in any event until the <b>31.07.2023</b> as documentation of the recall. This applies even if you have none of the listed products in stock or if these products do not exhibit the defect in question.</li></ul>
