## Urgent FIELD SAFETY NOTICE

Device: **Terumo® Extracorporeal blood circuits, Tubing sets and Ancillary devices**

Reference: **FSN 2102 -- 2021-05**

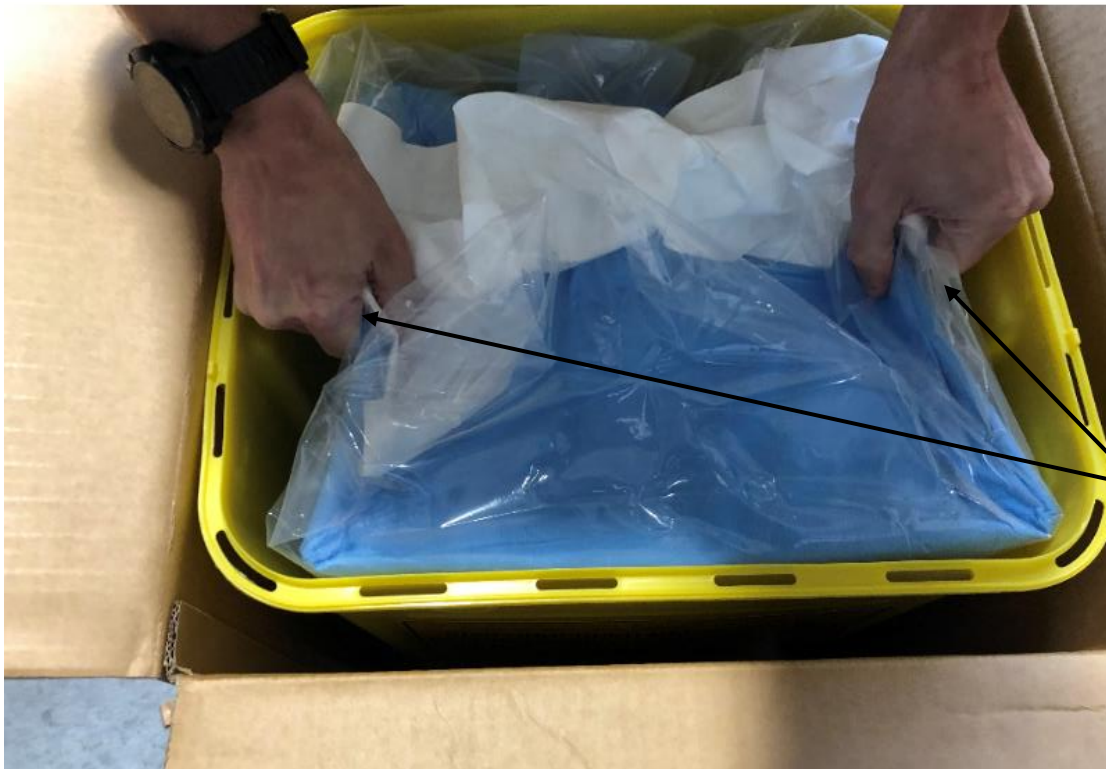
Image 2 – How to grip packs when removing

4. Remove the pack carefully by grabbing the plastic insert within the Primary packaging. Place one hand either side and pull by gripping both the product (within the plastic insert) and the packaging together. It is critical that you do not remove the pack by pulling only on the packaging. Image 2 shows how the pack is to be removed.

Remove the pack by placing one hand either side and pull by gripping both the product (within the plastic insert) and the packaging together as shown in image 2.

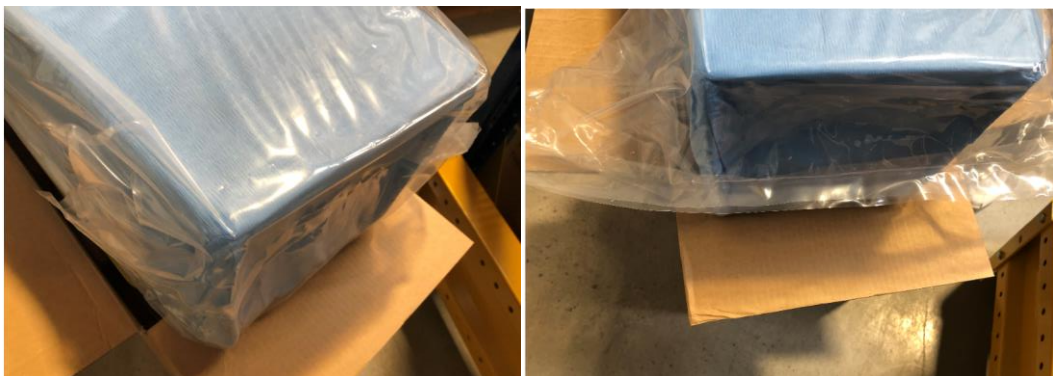
Image 3 – Pack as seen when removed from yellow bin

5. Once the packs have been removed place on their side and inspect packaging. The seal on the bottom of the pack should be intact as shown in image 3 below. If the pack has been removed by pulling on the gas bag without holding the plastic insert it is possible that the seal has come open (as shown in image 4). In this case the failure of the seal will be a wide opening of 10 – 15 cm.

Inspection – Inspect the bottom seal on removal: it should be sealed.

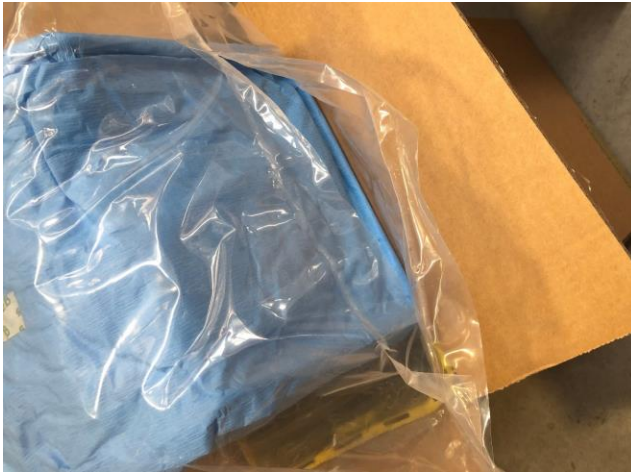
Image 4 – Example of an open seal.

Terumo Europe has received two complaints for Extracorporeal blood circuits, in which, whilst opening the packaging of the device, the perfusionist detected the outer bag was not sealed. Further investigation into the seals determined that on a specific sealer for a defined period of time, a full weld had not been obtained between the two films, resulting in a number of units with a seal which can be peeled open if during handling the weight of the product is transferred onto the sealed end of the packaging.

In the case that the seal is open the pack is to be discarded. An example of an open seal is shown in image 4 below.
