Field Safety Notice
Belzer UW[®] Cold Storage Solution; Belzer MPS[®]
& StoreProtect[®]

Field Safety Notice (FSN)
Belzer UW[®] Cold Storage Solution; Belzer MPS[®]
& StoreProtect[®]

Appendix B – Visual inspection for the Health Care Professionals

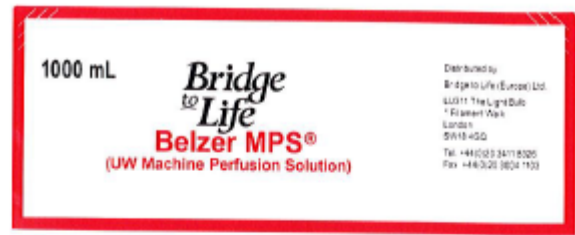
Bag labels

The reference number is located here

The lot number is located here

1. **Read** the "2.1. Description of the product problem" section carefully to fully understand the issue involved.
2. Please immediately **examine** your inventory stock to determine if you have any remaining product in your possession.
3. **Stop** any further sale and distribution/ usage of the affected product.
4. The following illustrations are provided to help you identify the products and lots. Affected lots are identified by the reference number and lot number on the bag and case labels.

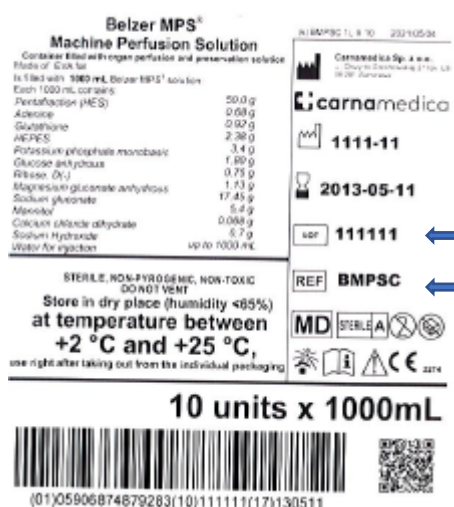
Case label

The lot number is located here

The reference number is located here

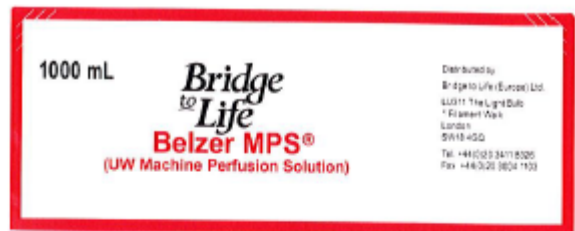
Bag labels

The reference number is located here

The lot number is located here

5. **Read** the “2.1. Description of the product problem” section of the attached FSN carefully to fully understand the issue involved.
6. Please immediately **examine** your inventory stock to determine if you have any remaining product in your possession (**see Appendix A to the FSN**).
7. **Stop** any further usage of the affected product.
8. The following illustrations are provided to help you identify the products and lots. Affected lots are identified by the reference number and lot number on the bag and case labels.

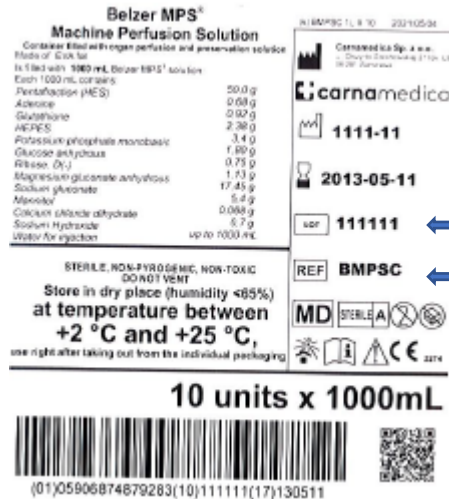
Case label

The lot number is located here

The reference number is located here

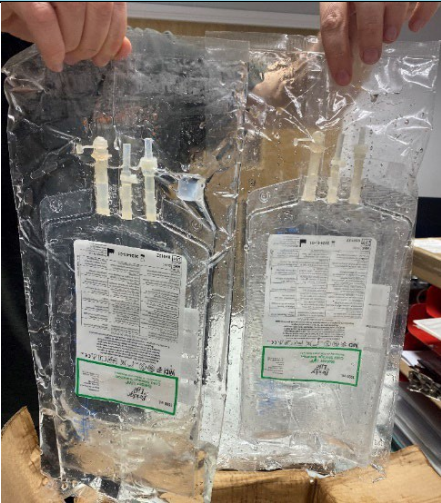
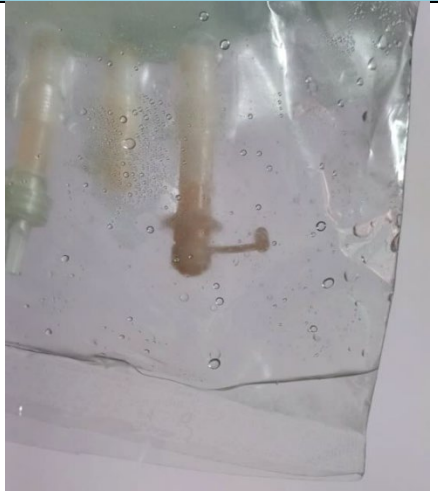
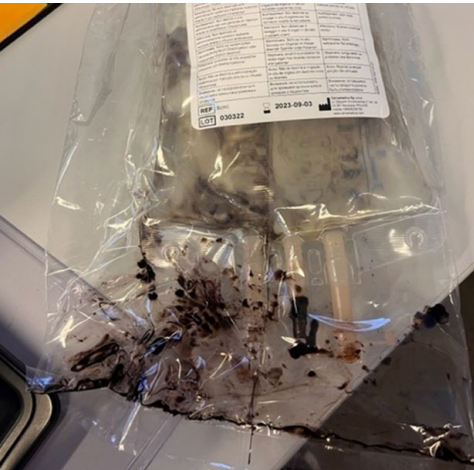
LEAKAGE

2.	<p style="text-align: center;">5. Further information to help characterise the problem</p> <p>Leakages and turbidity/ discoloration occur when the sterile barrier of the product is lost. Several factors can cause these defects: the EVA bag micro-sealing issue, the EVA bag injection port issue, the aseptic process issue. These issues affect only the individual affected bags, not the entire batch (LOT). The original issue is related to the individual EVA bags and can contribute to the aseptic process and result in microbiological contamination.</p> <p>The presence of visible particles in the solution is the result of overheating caused by failure to meet the manufacturer's specified transport/ storage temperature in the supply chain.</p>

Description:
Picture of Leaking Bag

7. **Dispose** of the affected products through waste system, recycle packaging and **document** that on the Customer Reply Form attached to this Notice. If there is no possibility to dispose of the product in this way, you may return the product to local Customer representative through your normal means.

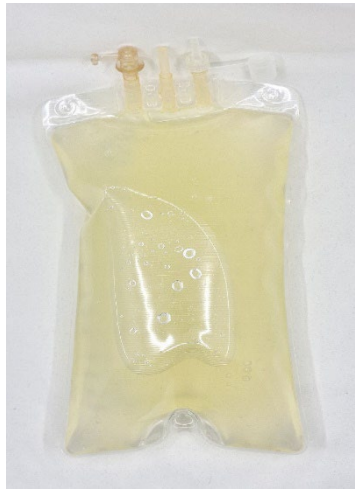
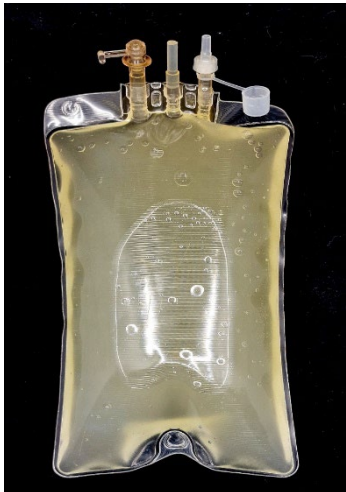
TURBIDITY/ DISCOLORATION

2.	<p style="text-align: center;">2. Hazard giving rise to the FSCA*</p> <p>A damaged or leaking bag could result in microbial contamination of the sterile solution path due to lose of the sterile barrier. The turbidity and obvious intense discoloration is an indication of microbial contamination. This may predispose patients to peritonitis, infection, sepsis and failure to graft. Additional potential hazards that may result include delay in therapy.</p> <p>If the visible particles are isolated in the device, local post-reperfusion ischemia may occur and there may be a potential risk of delayed graft function due to obliteration of some small vessels.</p> <p>The risk is mitigated by the end user during the organs' preparation procedure according to the Instructions for Use (IFU), section PREPARATION. It is an obligatory standard for the end user to check each container that is used for presence of leakage/ discoloration or foreign particles, before the solution is administrated into the organ. In case that the solution contains any visible particles/ discoloration/ leakage, the product must be discarded and cannot be used for the patient.</p>

Description:
Picture of the turbid/
discolored solution
