**URGENT Field Safety Notice**

Trilogy 100 and Trilogy 200  
Silicone Sound Abatement Foam Delamination

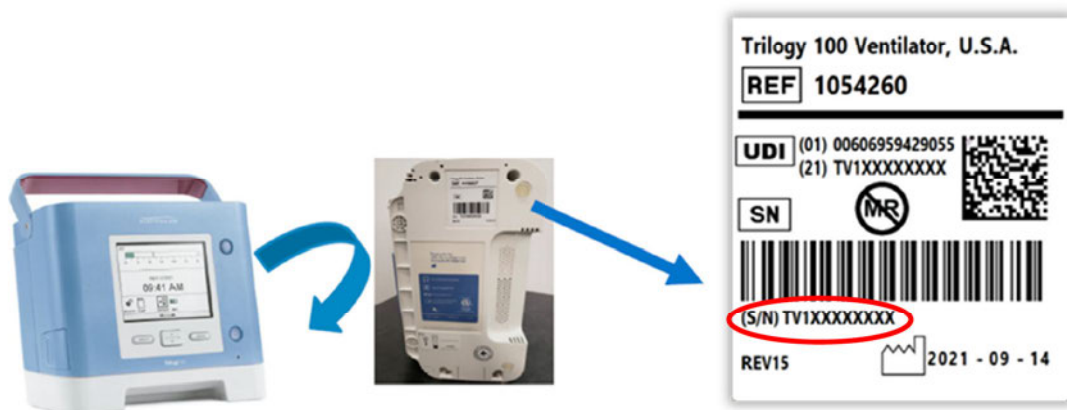
A list of equipment affected by this issue is included with this letter. The devices are identified by Serial Number. The Serial Number is located on the bottom of the Trilogy Ventilator.
