URGENT FIELD SAFETY NOTICE

GEHC Ref# 32072

RE: Giraffe Blue Spot PT Lite Phototherapy Systems—Light Output May Fall Below the Recommended Minimum Output Due to Fiber Protrusion.

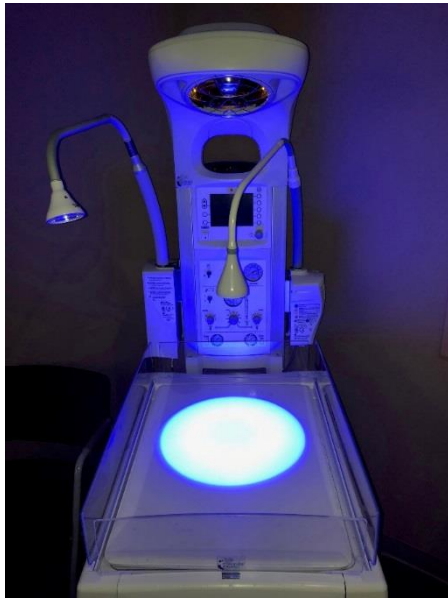
Normal / Focused Output Light

Elevated heat can cause the light pipe optical fiber to protrude through its reflector aperture, creating an unfocused spot with less than $27\mu\text{W}/\text{cm}^2/\text{nm}$ output as described above. The photos below show the effect and can be used in conjunction with the BiliBlanket Meter II bilimeter to identify units with a low light condition due to elevated heat exposure.

Shade is 15 in. (38 cm) from mattress pad
 Output has well-defined edges
 Output is a 14 in. (35.5 cm) dia. circle
 Light intensity uniform

Take out of service any units found to have irradiance levels less than $27\mu\text{W}/\text{cm}^2/\text{nm}$ and await the free kit to correct the unit that GE Healthcare will be sending for all potentially affected units.

To correct any existing devices experiencing low light output due to fiber protrusion and to prevent potential future low light output due to fiber protrusion, **GE Healthcare will send a kit to fix all potentially affected units free of charge** beginning early February 2020. The kit will include the replacement shade with installation instructions. A resident biomed technician can easily and quickly install the replacement shade in a few minutes. For devices with fiber protrusion and outputs below $27\mu\text{W}/\text{cm}^2/\text{nm}$, this replacement will bring your device's back to a factory new output between $36\mu\text{W}/\text{cm}^2/\text{nm}$ and $56.25\mu\text{W}/\text{cm}^2/\text{nm}$. The kit will also include a Preventive Maintenance addendum to the existing Operation, Maintenance, and Service Manual.

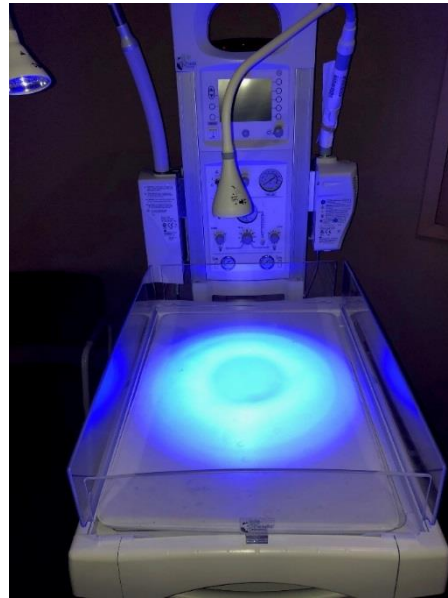
Abnormal / Unfocused Output Light

Shade is 15 in. (38 cm) from mattress pad
 Output has diffused, ill-defined edges
 Output is a 16-19 in. (40.6-48.2 cm) dia. circle
 Dull center surrounded by an intense band

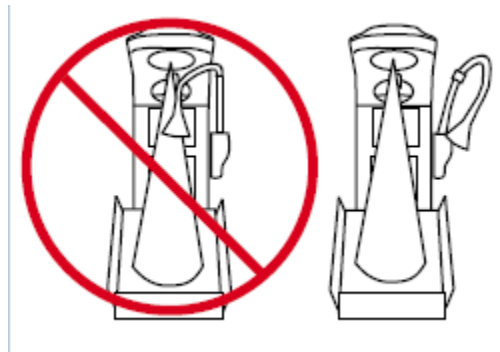
- As previously stated, exposing the shade head to elevated heat from the warmer is contra-indicated with this device. To prevent potential damage to light pipes due to elevated heat, we remind that care should be taken to position the light pipe, as shown in the Instructions for Use Section 2.2 "Operation" and in the Quick Reference Guide, keeping the light pipe Shade head outside the direct path of warmers (see figure below).

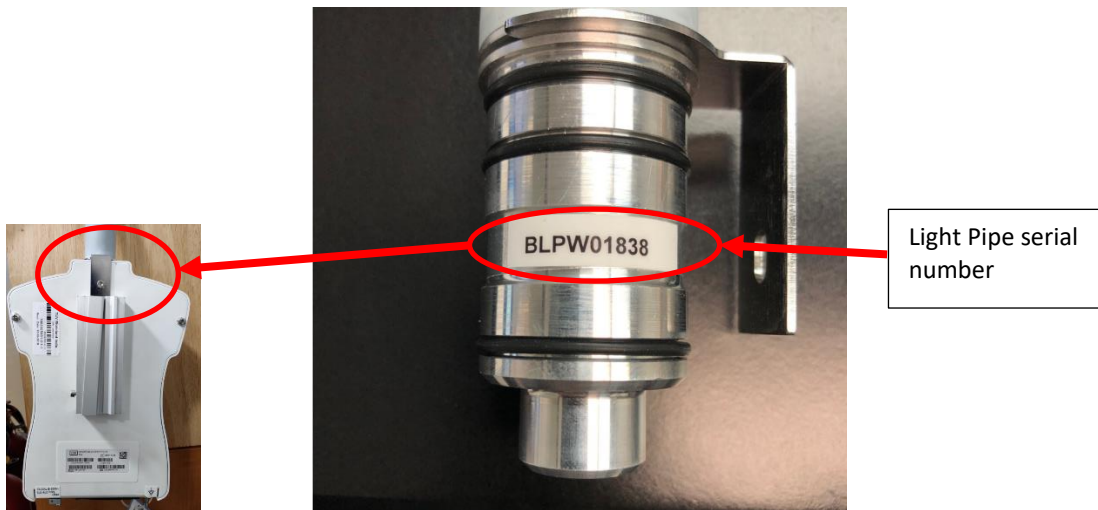
To locate the Light Pipe serial number, remove the light pipe by referring to Service Manual Section 7.4.1

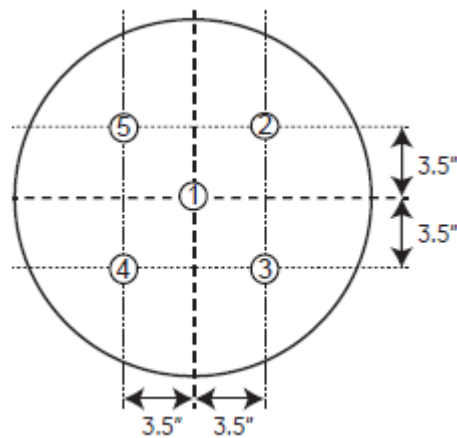
Figure 2-1 Light Measurement Points

1. Connect the power cord to an appropriate power source. The standby/on indicator will light green to indicate standby mode.
2. Press the standby/on switch to turn on the therapeutic light. The standby/on indicator will change from green to blue and the over-temperature/under-temperature indicators will briefly illuminate.
3. Keep your hand close to the exhaust vent when the device is on to feel the air flow coming out of the device to confirm that the fan is operating.
4. Focus the therapeutic light so that the spot diameter is 35.5 cm or when the shade is 38 cm from the bed surface.
5. Using a calibrated Biliblanket Light Meter II, measure the light at the 5 points indicated in Figure 2-1 and calculate their average. Confirm that the average is at least $27 \mu\text{W}/\text{cm}^2/\text{nm}$.

6. Divide the lowest reading by the highest reading. If the LED light is functioning properly, the result should be greater than 0.4. If the result is not greater than 0.4, contact service.

1. Immediately check all your device outputs using a BiliBlanket Meter II bilimeter and continue to do so prior to every use, as listed in the Instructions for Use as well as during the treatment session. Instructions as to how to measure your device's output are provided in both the Operation, Maintenance, and Service Manual Section 2.1 "Pre-Use Checkout Procedure" and in the Quick Reference Guide attached to every unit and are detailed below in Appendix 1.
