Safety Advisory Notice

To all users of the SIEMENS AXIOM Aristos FX

Re: AXIOM Aristos FX systems; possible drop of the cable holder

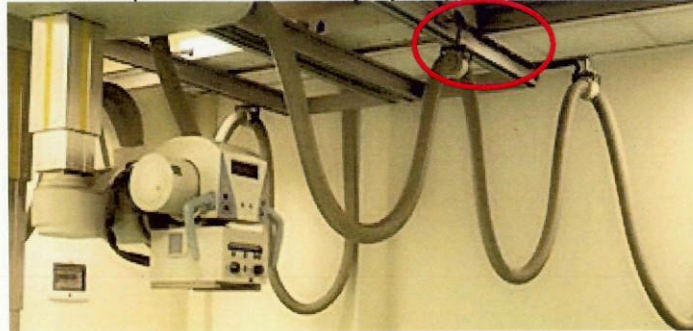
picture 1

In case, the 3 wheeled cable cart moves behind the point of the fixed cable holder, the corrugated hose may get stuck behind the hose from the fixed cable holder (picture 1).

In case the cable cart and the corrugated hose cannot move freely, the cable cart may get pushed out of the ceiling suspension if pulled into the direction of the tube stand. If this occurs, there is a potential for the cable holder to drop down and hit patients or system operators.

Please ensure, that the corrugated hose does not get caught behind the hose from the fixed cable holder and that it can move freely (picture 2).

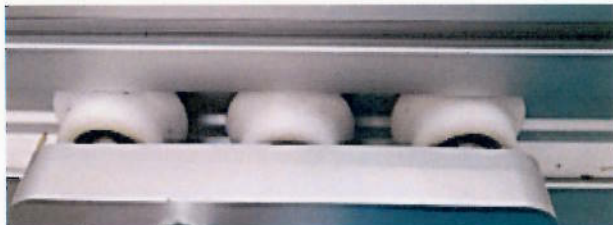
picture 3

Only the cable holders with 3 wheels are affected (picture 3). Cable holders with 4 wheels are not affected by this malfunction.

- Siemens is preparing a field modification (UI XP091/14/S) for all AXIOM Aristos FX systems that will resolve this potential malfunction.
