URGENT FIELD SAFETY NOTICE

GEHC Ref# 12283

RE: **Senographe Pristina with Serena – Potential slippage of the biopsy positioner when the gantry is rotated during a biopsy procedure.**

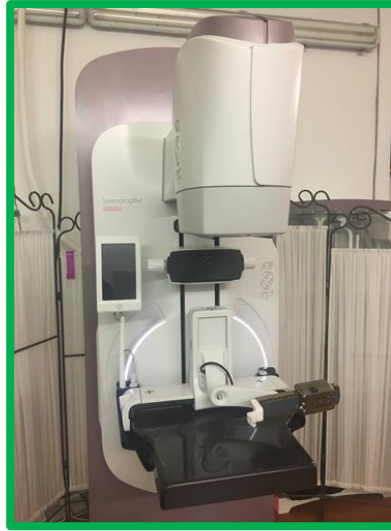
Figure #2 – Acceptable Gantry Position for Biopsy Procedure: Senographe Pristina gantry rotation angle is 0°. Horizontal approach setup.

- You may continue to perform biopsy procedures when the Senographe Pristina gantry is **not** rotated in vertical or horizontal biopsy approaches. See Figure #1 and #2.
- **Do Not Use** your Pristina Serena system to perform biopsy procedures at **any** gantry rotation other than 0°. See Figure #3 & Figure #4.

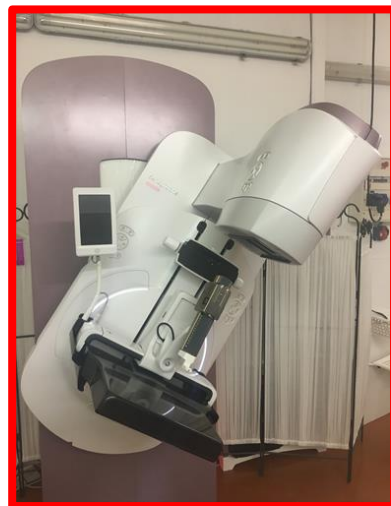
Figure #4 – Do Not Use Gantry Rotation for Biopsy Procedure: Senographe Pristina gantry at ANY rotation different from 0°.

If the Senographe Pristina gantry is rotated and the biopsy positioner is attached, the angulation angle may unexpectedly change during a motorized angulation motion, due to insufficient brake performance. This issue could result in injury to the patient's breast. No injuries have been reported due to this issue.
