## Field Safety Notice RadiForce RX360 and GX560 Abnormal image displayed

## Field Safety Notice (FSN)

### RadiForce GX560 and RX360 Abnormal image displayed

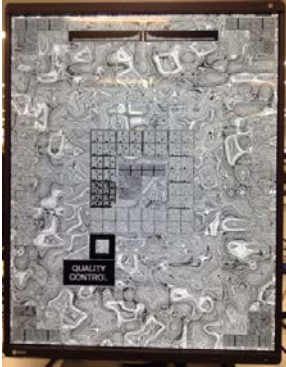
<p>Abnormal Display</p> </div> <div style="text-align: center;"> <p>RadiForce RX360</p>

2. Reason for Field Safety Corrective Action (FSCA)*	
2.	<p>1. Description of the product problem*</p> <p>The following marble pattern fairly infrequently appears when one of the following conditions are met.</p> <ul style="list-style-type: none"> <li>Turning the power off and on by touching power switch in front of the monitor</li> </ul>

2.	<p>2. Hazard giving rise to the FSCA*</p> <p>EIZO concluded there is no risk of misdiagnosis since it is easily recognized by user in case of an abnormal display.</p>

3. Type of Action to mitigate the risk*		
3.	<p><b>1. Action To Be Taken by the User*</b></p> <p>If you see abnormal display, please stop using your monitor and eliminate the phenomenon by turning the monitor's main power off and on again.</p> <div style="text-align: center;">

3.	3. Is customer reply required? *	No
3.	<p><b>4. Action Being Taken by the Manufacturer</b></p> <p>On-site device modification/inspection and Software upgrade</p> <p>A firmware update is now being prepared to solve this issue. The correction will consist of a software (firmware) upgrade and will be provided free of charge to all devices affected by this issue. An EIZO representative will contact customers with affected devices to arrange for installation of the upgrade.</p>	
3	5. By when should the action be completed?	31th December, 2020

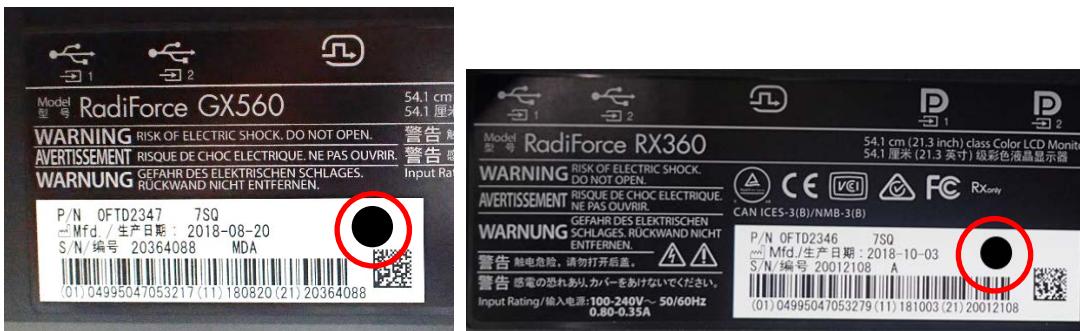
Black Dot Mark

<sup>1</sup> Monitor with a black dot mark on the nameplate are unaffected by this issue (see below)

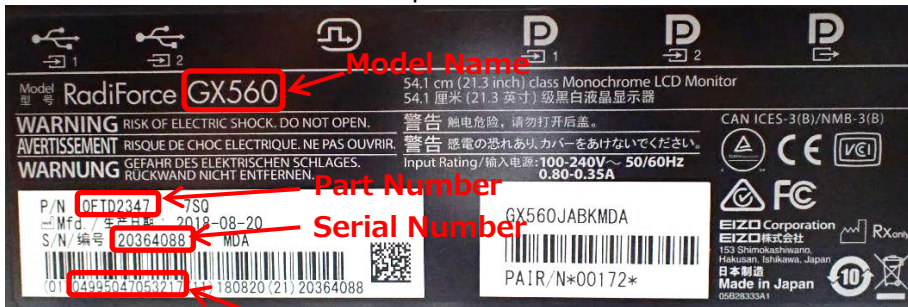
**RadiForce GX560 Name Plate Sample**

A) Referring to the name plate located on the back of the monitor.
