To all user of the following systems AXIOM Artis / Artis zee / Q / Q.zen

Corrective Action ID: AX068/20/S

Customer Safety Information (CSI) for Field Safety Corrective Action

Subject: Addendum of the tooth belt cleaning for AXIOM Artis, Artis zee, Artis Q and Artis Q.zen

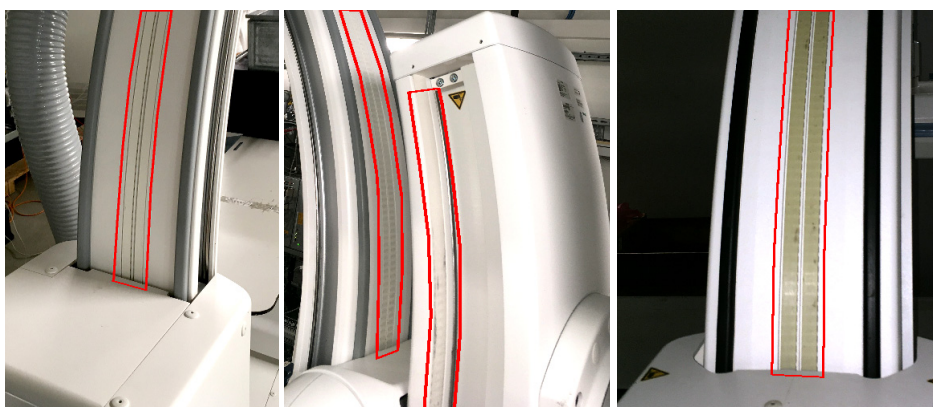
Examples of belts

Due to inappropriate cleaning, some Artis systems show unexpected corrosion of visible belts, which are needed to move system parts (e.g. C-Arm). This issue occurs sporadically and is not considered as a systematic issue.

Safety information - cleaning units which have a visible belt

Pay special attention when cleaning units (stands) which are equipped with a visible belt.

Observe the following information for cleaning:

- Do *not* use cleaning agents containing *aldehydes*.
- Do *not* use *spray bottles*.
- Perform *dry* cleaning, if possible.
- Use *little* cleaning agent or only water, if possible.
- ◆ *Wipe dry*.
